Re: w20a-4-09-2025 - Permit No. 6-21-0375 (Joseph Steinberg, Encinitas/Solana Beach)

Steinberg Seawall at South Cardiff State Beach 60" Passive Erosion since 1988

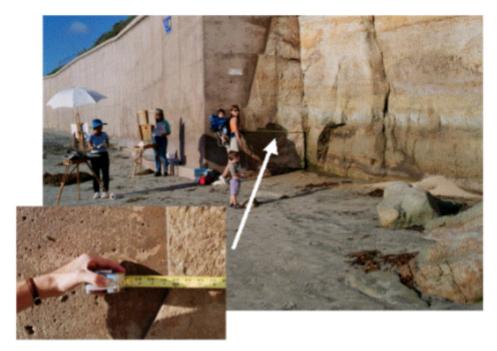
This passive erosion commenced almost immediately after seawall construction and prior to the construction of the erodible fill. This photo from about 2001 shows approximately 60" of 5 ft of erosion prior to the construction of the erodible fill. Note the block falls in the immediate vicinity.

Passive Erosion at Steinberg Seawall as observed in approximately 2001

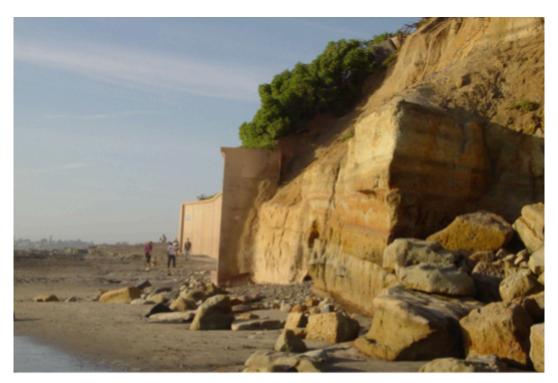
The below photos from 2005 and 2025 showing continued erosion and block falls.

Passive Erosion at Steinberg Seawall as observed in 2005. Note the presence of eroded blocks and an already constructed fill and return wall.

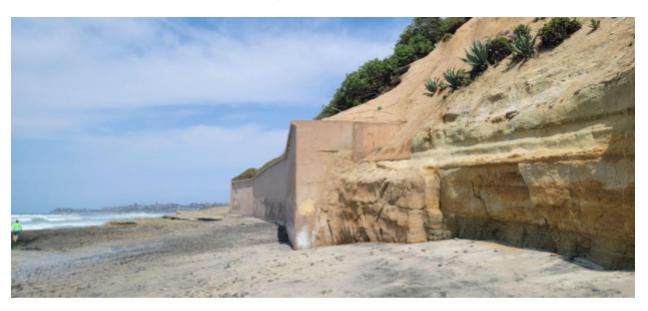
Passive Erosion at Steinberg Seawall as observed in March 2025. Note the continued erosion of the adjacent area to the south of the seawall. Also note the presence of wave driven cobble immediately shoreward of the seawall.

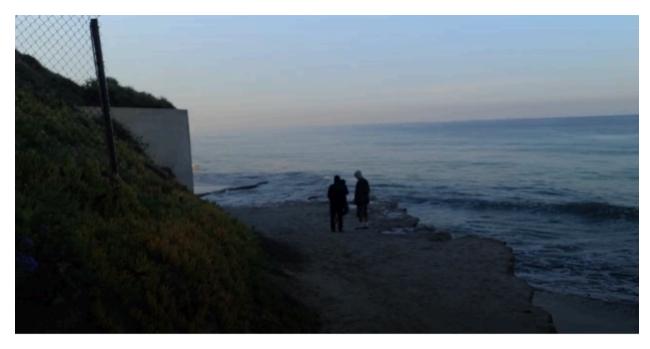
The area in front of the seawall is a primary access to the State Beach at medium to high tides and will progressively become the only access with rising sea level and continued erosion of the shore platform. See for example this photo below from January 2022

Beach access along bedrock platform at Steinberg Seawall as observed in January 2022. This access connects the southern portion of the State Beach to its parking lot and pedestrian access from South Coast Highway 101.

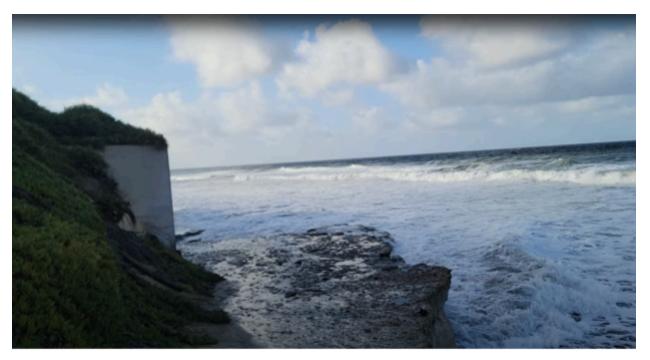
Even under current sea levels, waves periodically overtop elevated bedrock platform and flood areas in front of the seawall in public easements and below the property line as well as to the property line.

Flooding of beach access to South Cardiff State Beach and front of Steinberg Seawall as observed on November 15, 2024.

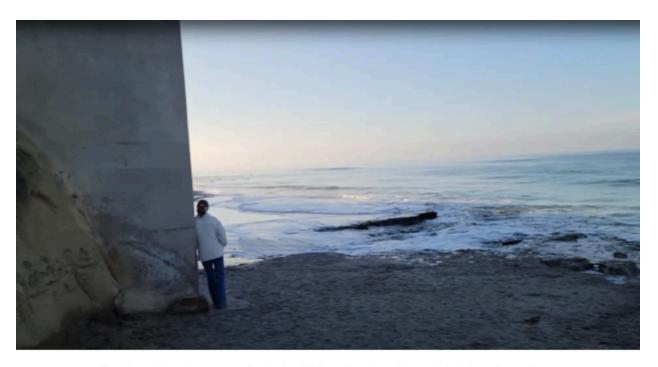
Flooding of beach access to South Cardiff State Beach and front of Steinberg Seawall as observed on December 23, 2022.

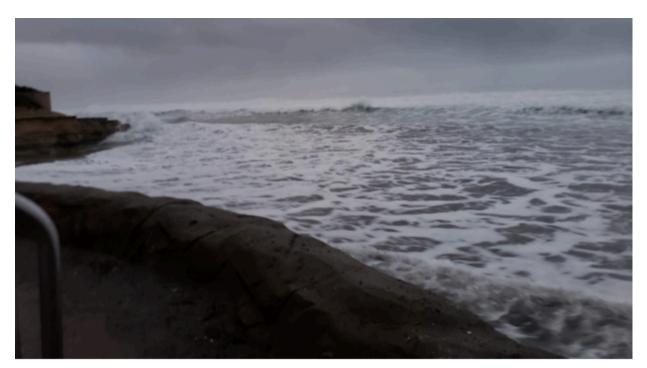
Flooding of beach access to South Cardiff State Beach and front of Steinberg Seawall as observed on January 18, 2019.
