Las Encinas Creek Habitat Restoration
Alternatives Analysis Report

City of Carlsbad

19 January 2023

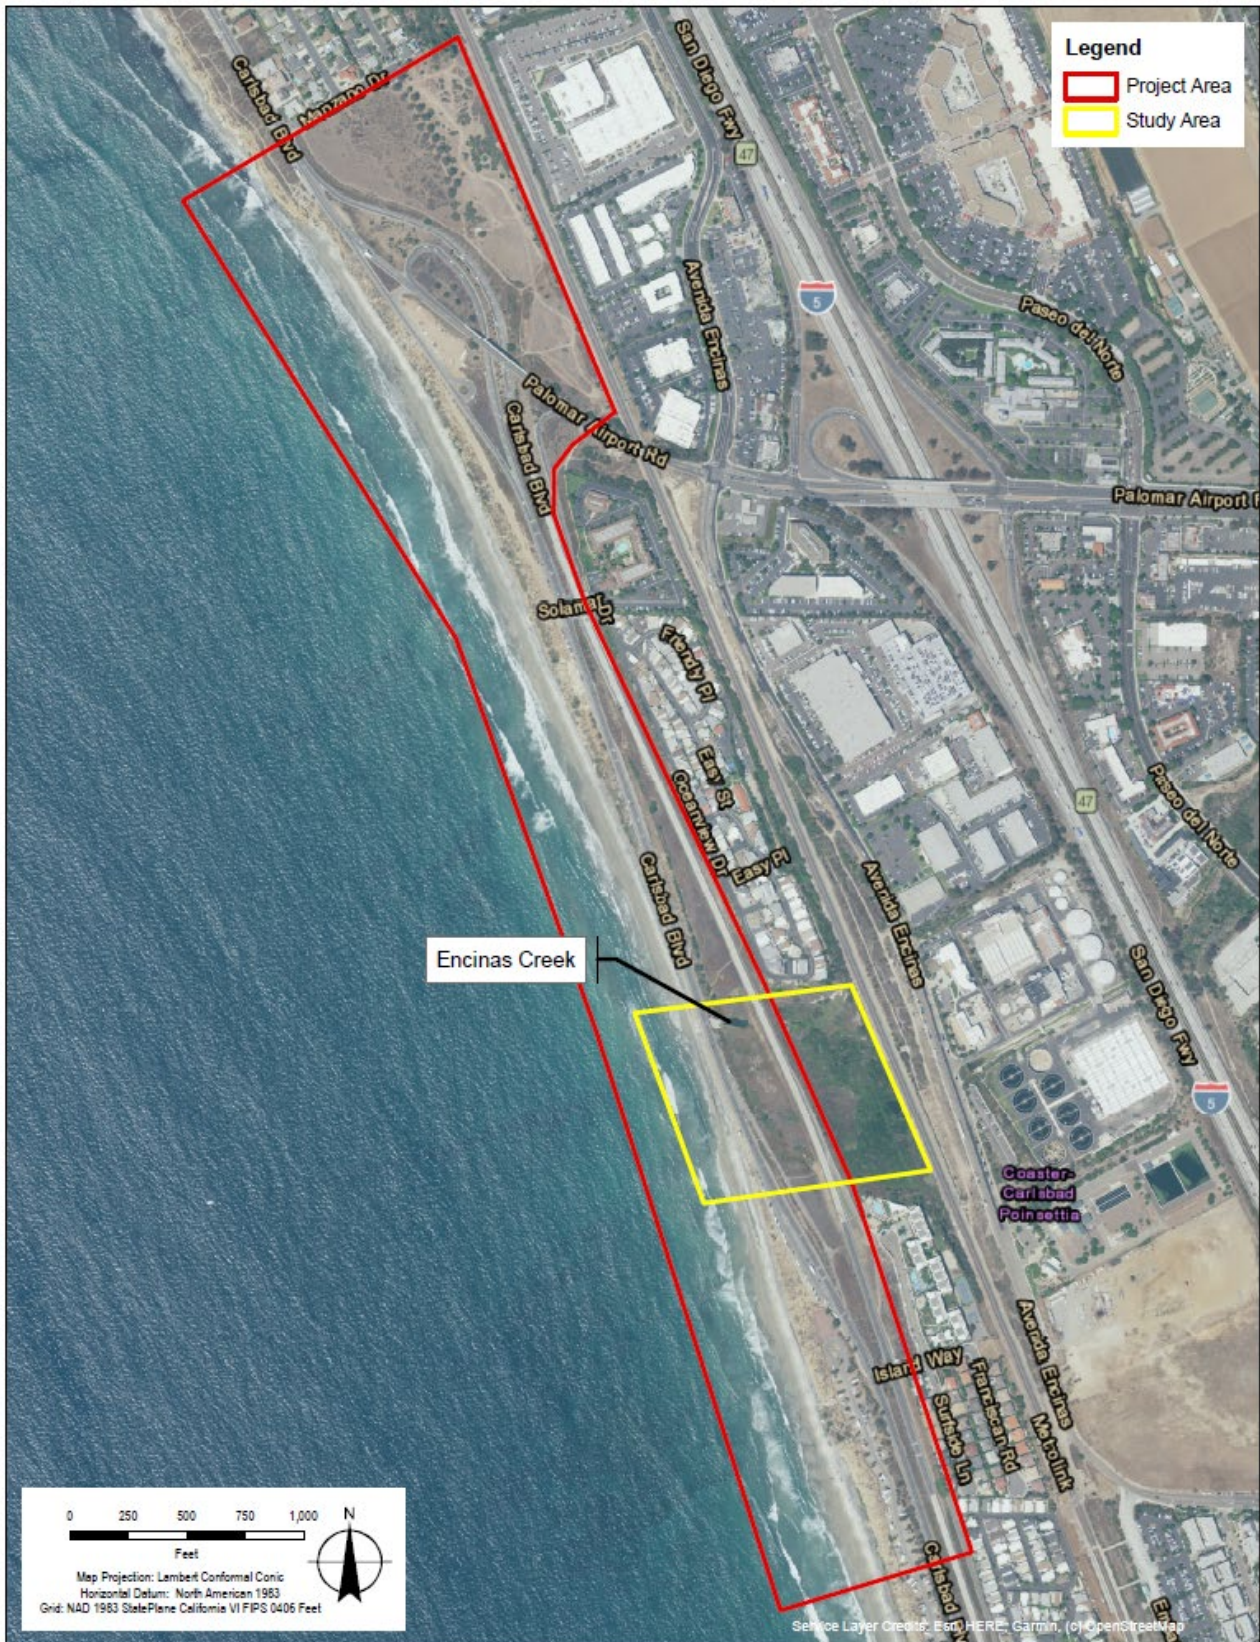
Figure 1-1. South Carlsbad Boulevard Climate Adaptation Project – Las Encinas Creek Habitat Restoration Study Area

During the design phase of the Project and specifically during stakeholder outreach activities, questions arose surrounding whether the Project should be phased over time or initially built to the ultimate (i.e. 2120-time horizon) configuration. These two phasing options are being referred to commonly within this study as “Phased Adaptation” or “Retreat Now”. Key themes around the question of phasing relate to the proposed uses of these abandoned spaces and the types, function and viability of habitat restoration options at Las Encinas Creek in each of these scenarios. This study seeks to help answer questions regarding the quality and resilience of habitat restoration options at Las Encinas Creek as they relate to the two Project implementation options being considered. The Study Area is focused on the Las Encinas Creek area to inform implementation phasing in this segment of the Project Area (Figure 1-1).

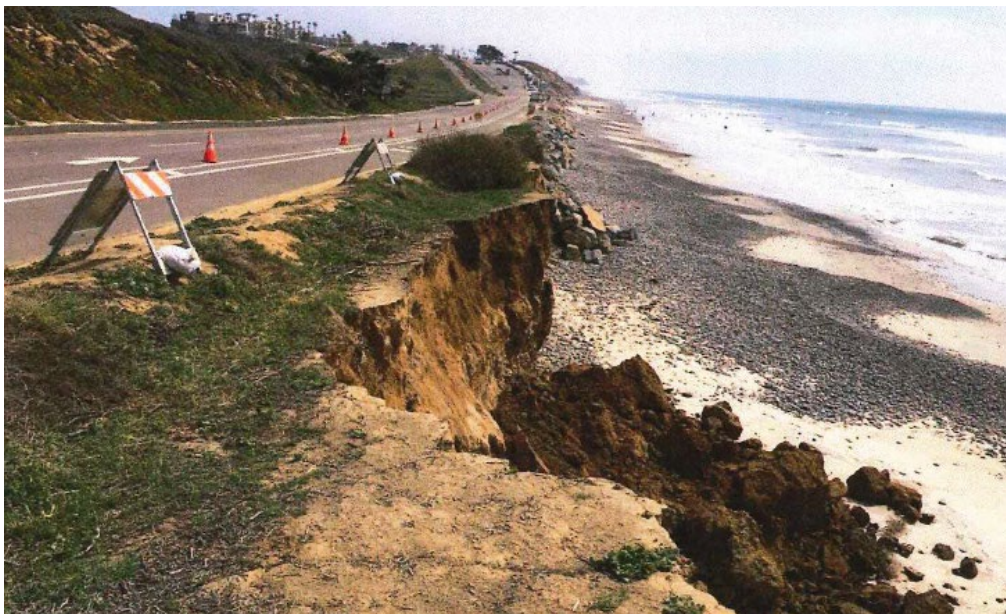
Figure 3-4. Erosion along Southbound Carlsbad Boulevard near Encinas Creek (Photo taken 3/17/2016 by City of Carlsbad)

The cliff fronting South Carlsbad Boulevard in the vicinity of Encinas Creek has a history of erosion and instability. Slope stabilization of this approximately 1,300-foot segment has occurred through three incremental placements of rock shoreline protection (RSP) from 2009 to 2016. The RSP is a two to four ton rock placed at a 1.5:1 (H:V)¹ slope underlain by a geotextile fabric. The last segment of RSP was placed during the 2015/2016 El Niño winter where a succession of wave events caused significant erosion and cliff/roadway instability (Figure 3-4), which led to a partial closure of the roadway and emergency repair work. The California Coastal Commission permit granted during that time was conditional on the completion of an analysis of viable alternatives for this area. A study was prepared titled *Final Alternatives Analysis Report: Las Encinas Revetment* (Moffat & Nichol 2017), which looked at various shoreline protection options alongside a roadway realignment option. The City requested a five year permit extension from the California Coastal Commission to develop a long-term management plan for the roadway that incorporates one of these alternatives. This Project is in direct response to this long-term management plan requirement.

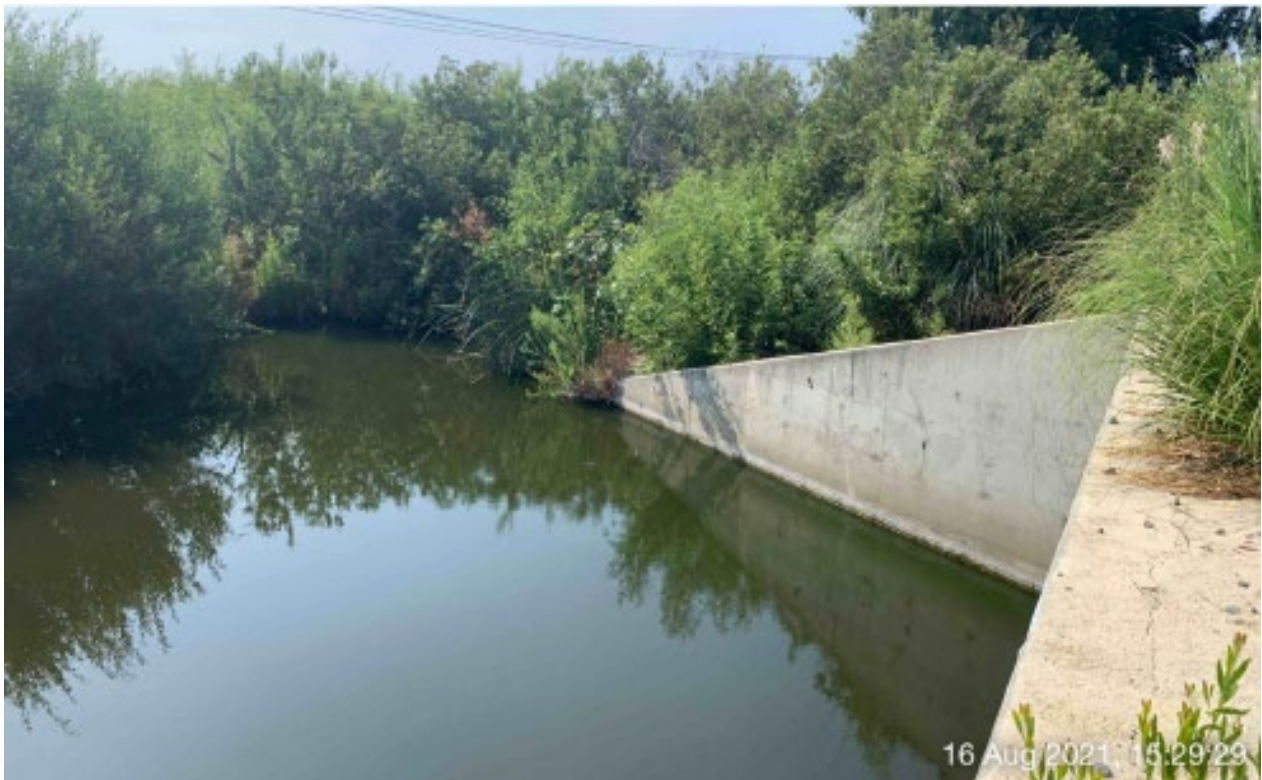
Figure 3-6. Large scour pool at the outlet of the large culvert under Avenidas Encinas

Encinas Creek morphology has been highly altered by upstream urbanization, culverts and shoreline modifications. Urban stormwater runoff has likely increased frequency and magnitudes of peak flow rates and velocities, resulting in channelization of Encinas Creek between the rail prism and Northbound Carlsbad Boulevard. A deep scour pool exists at the large culvert outlet below Avenida Encinas/rail prism at the southeastern end of the Study Area (Figure 3-6), and seasonal channels radiate out from the pool, with one small perennial channel flowing west to the toe of the Northbound Carlsbad Boulevard bank.

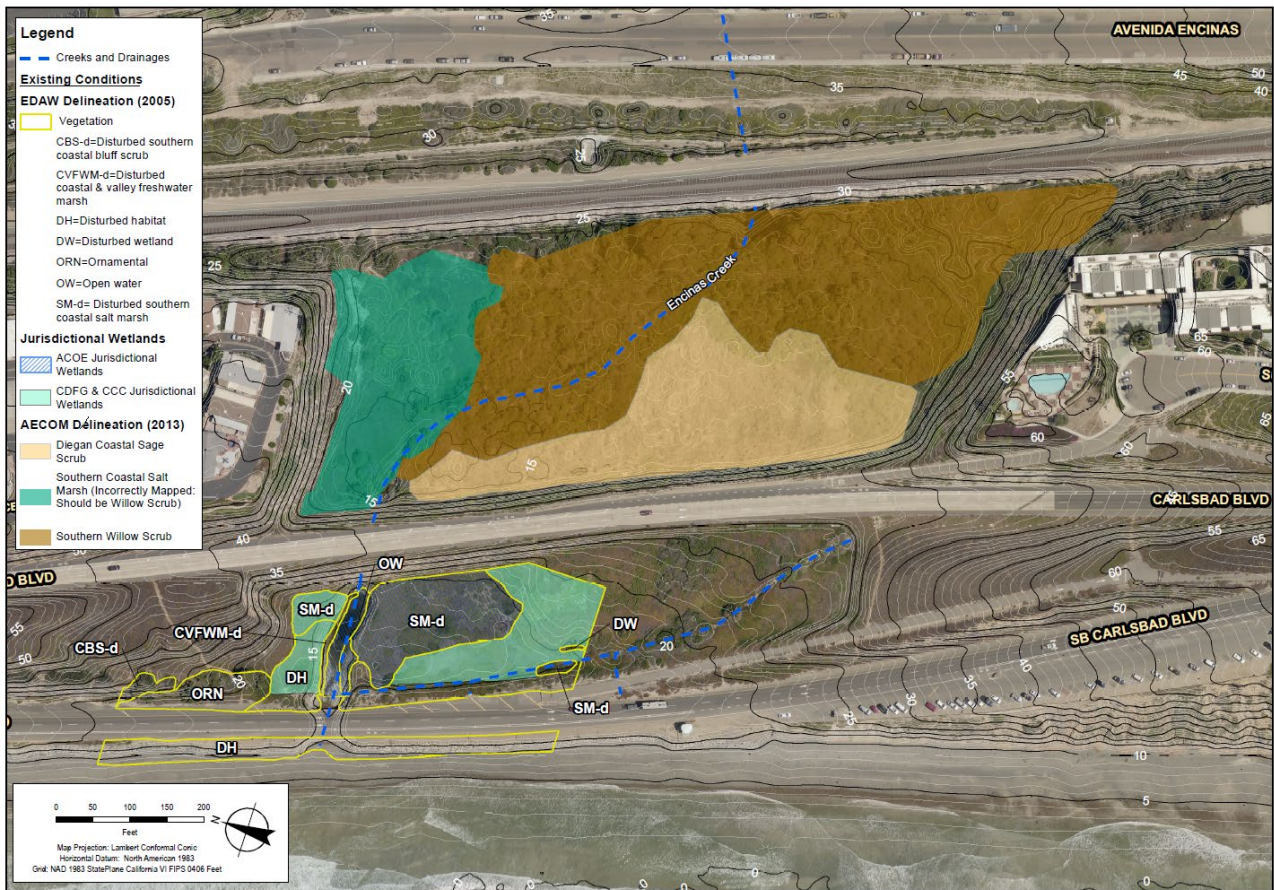
Figure 4-1. Previous habitat mapping by EDAW and AECOM

At the eastern segment of the site, between Northbound Carlsbad Boulevard and the rail prism, vegetation had previously been mapped as Diegan coastal sage scrub, southern willow scrub, and willow scrub/coastal salt marsh (Figure 4-1). To the west of the Northbound Carlsbad Boulevard, much of the area was described as disturbed southern coastal salt marsh or disturbed habitat (Figure 4-1).

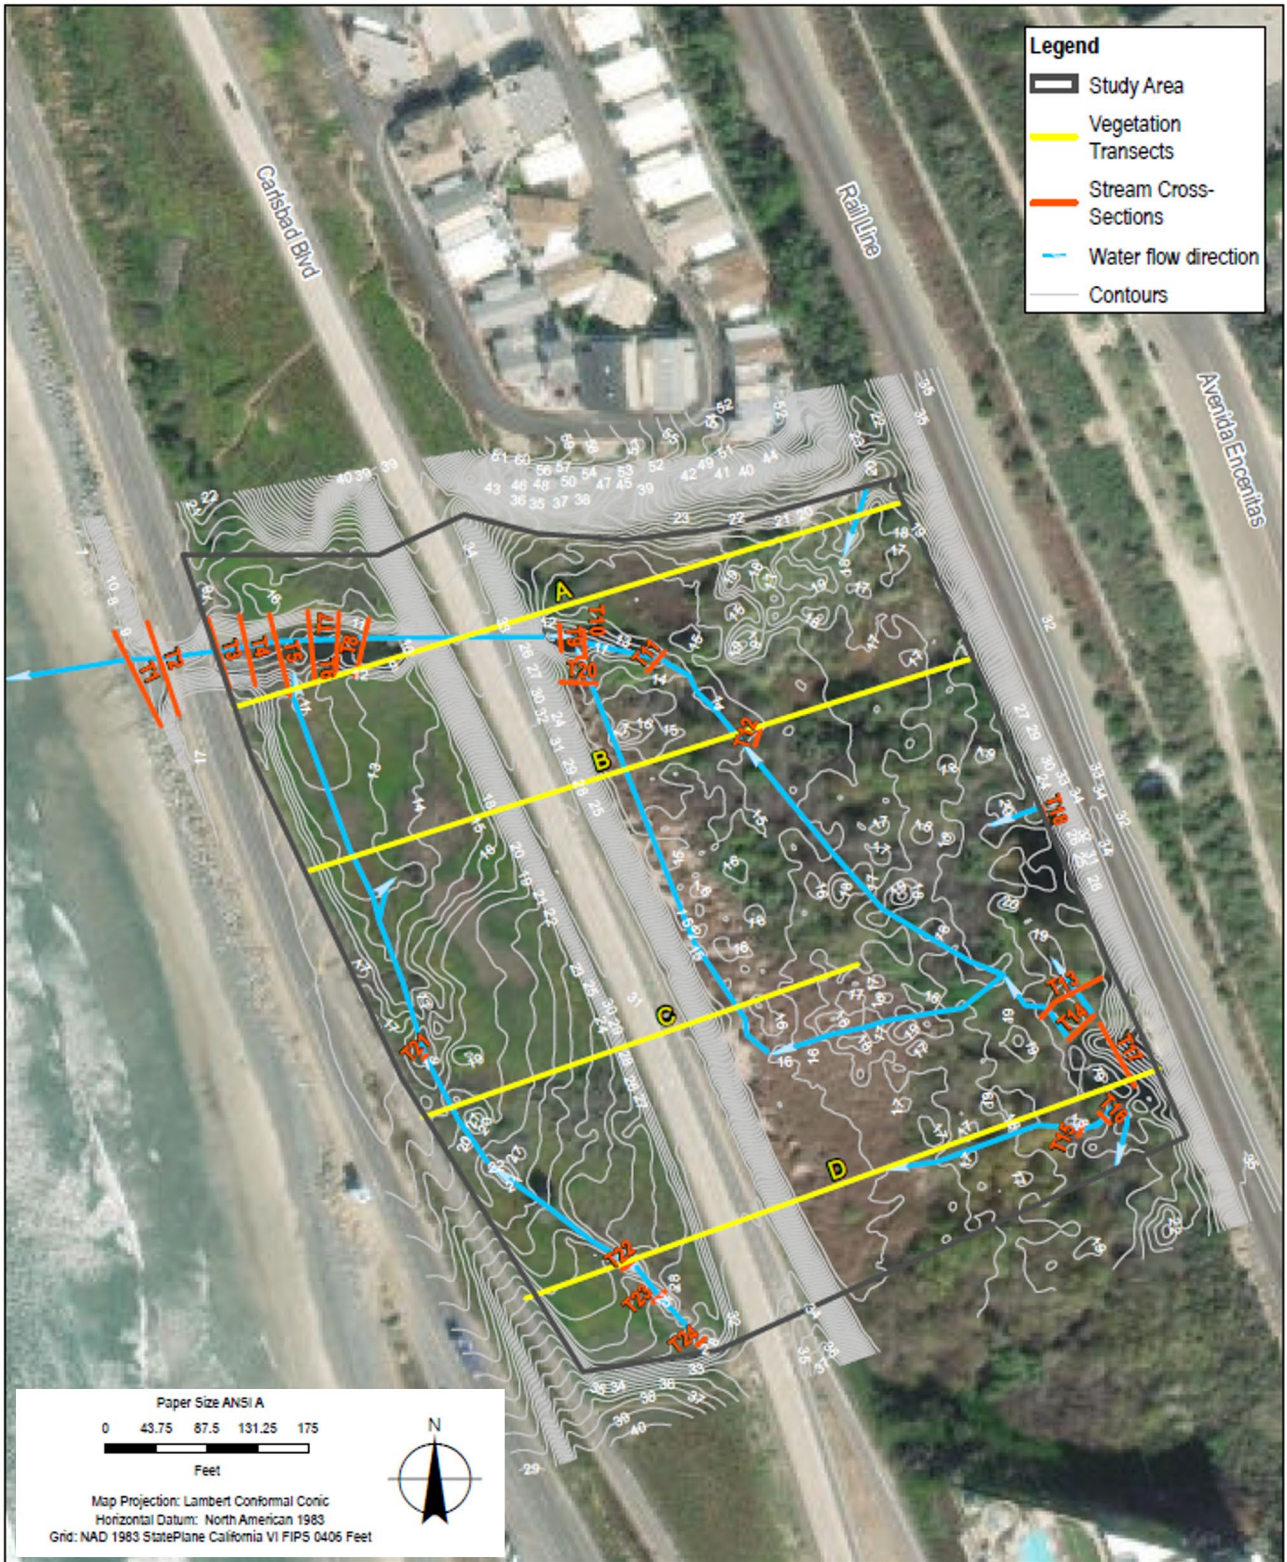
Figure 4-4. Topography and Hydrology of the Study Area

The results of the habitat, hydrologic and topographic mapping are shown in Figure 4-3 and Figure 4-4. Much of the site is dominated by iceplant and non-native scrubs. There is also a strong presence of Arroyo willow, cattail marsh, and pickleweed marsh. The topographic/hydrologic mapping found three main channels that flow into Encinas Creek, one of which results from a stormwater conveyance feature found at the southern extend of the Study Area. The other two flow paths originate from the scour pool at the culvert under the railway prism. These results will be discussed in more detail in the following sections.

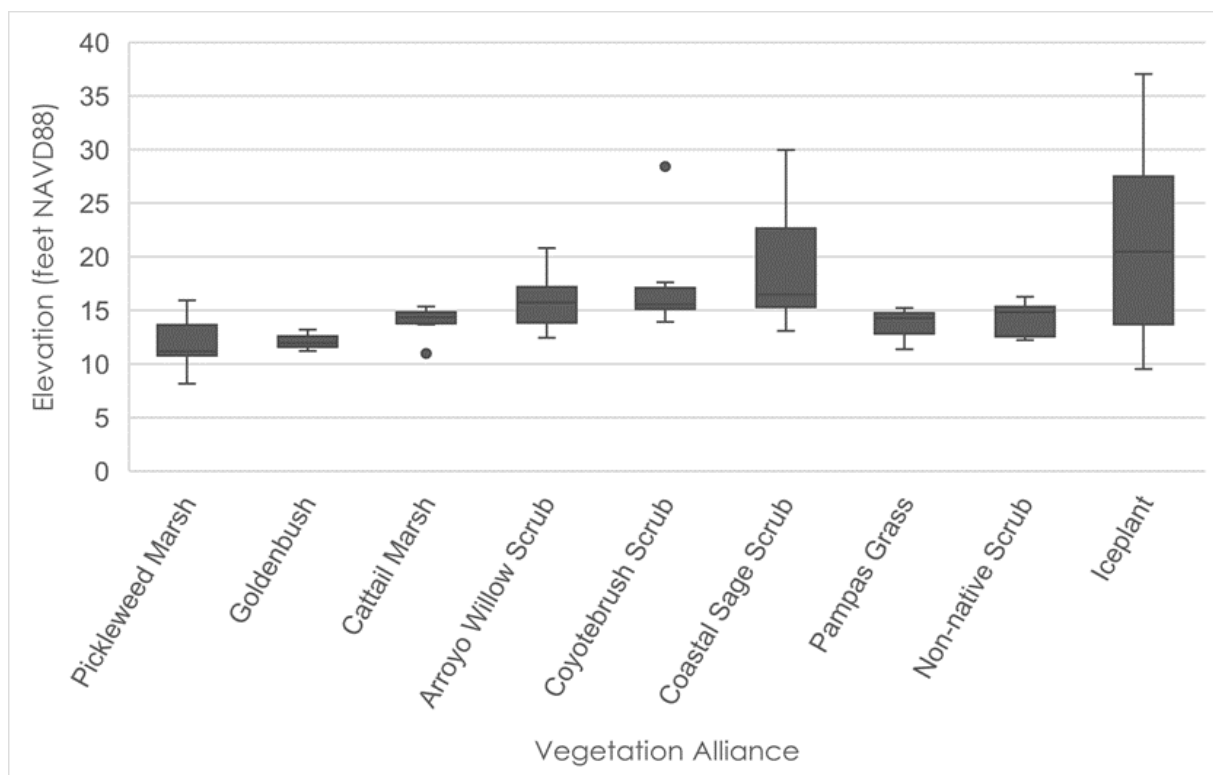
Figure 4-6. Vegetation Alliance elevation bands within the Study Area

The total acreage of each vegetation type mapped within each habitat is provided in Table 4-1 below. The brackish to saline pickleweed and Menzies goldenbush marsh vegetation alliances were found at the lowest elevations (Figure 4-6). Freshwater cattail marsh, pampas grass (invasive), and non-native scrub (invasive) was observed at low-to-mid elevations. Arroyo willow scrub was found at mid-to-high elevations around Encinas Creek. Coyote brush scrub and coastal sage scrub was also observed at mid-to-high elevations. Iceplant (invasive) has invaded a wide elevational range, and it was particularly dominant along the high-elevation road prisms.

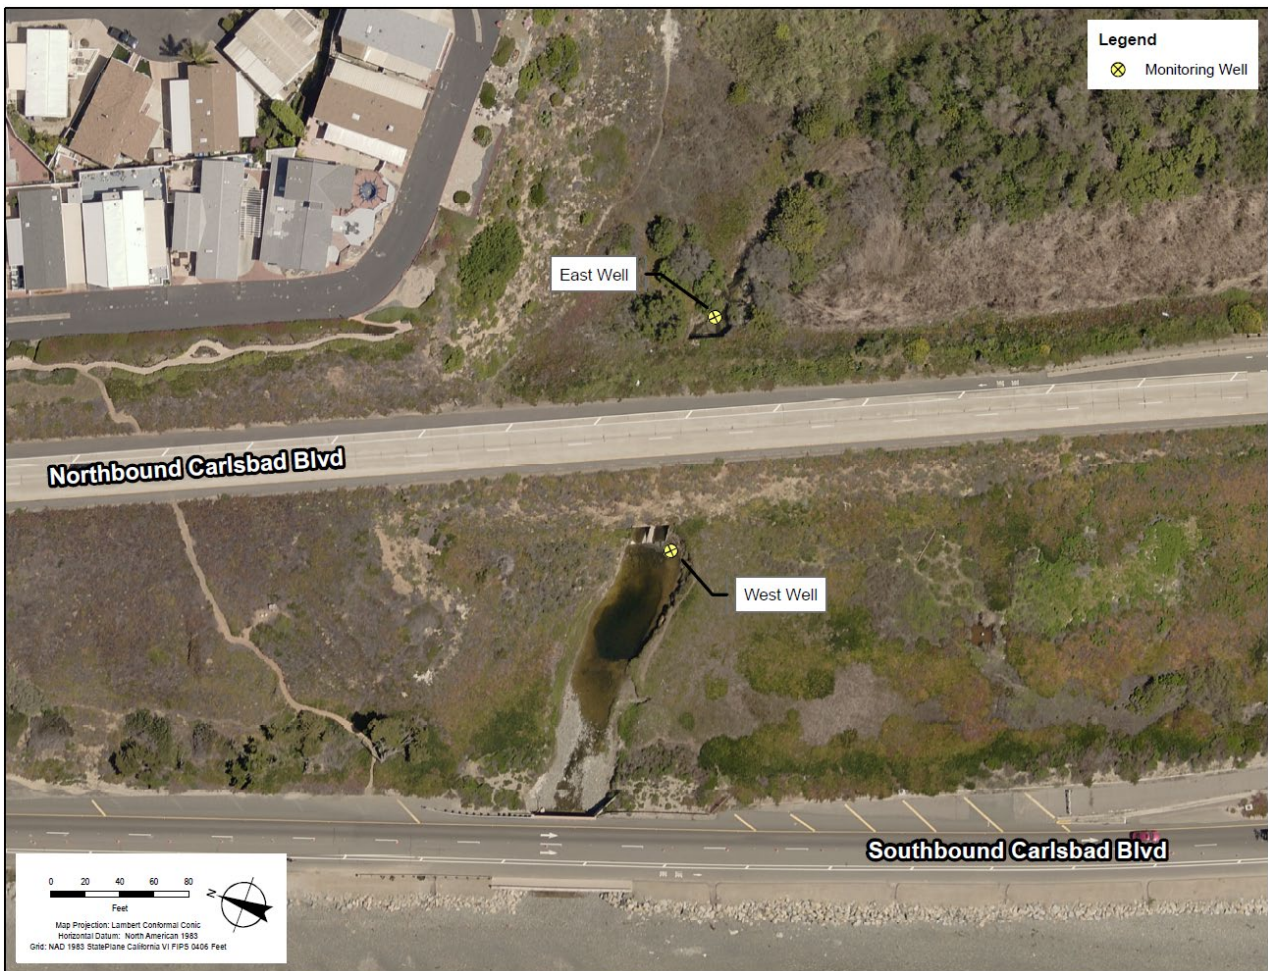
Figure 5-1. Las Encinas Creek Monitoring Well Locations

The instruments log data continuously at 15-minute intervals and data was downloaded manually monthly. Post-processing of data was performed using the Solinst Levellogger™ software. Additionally, post-processing includes referencing the observed water level data to a benchmark elevation. Benchmark elevations were collected during the initial topographic surveys. The western benchmark is located at the first concrete step southern culvert wall and is an elevation of 9.31 feet (NAVD88). The eastern benchmark is located on the eastern extent of the concrete pad and is an elevation of 9.72 feet (NAVD88).

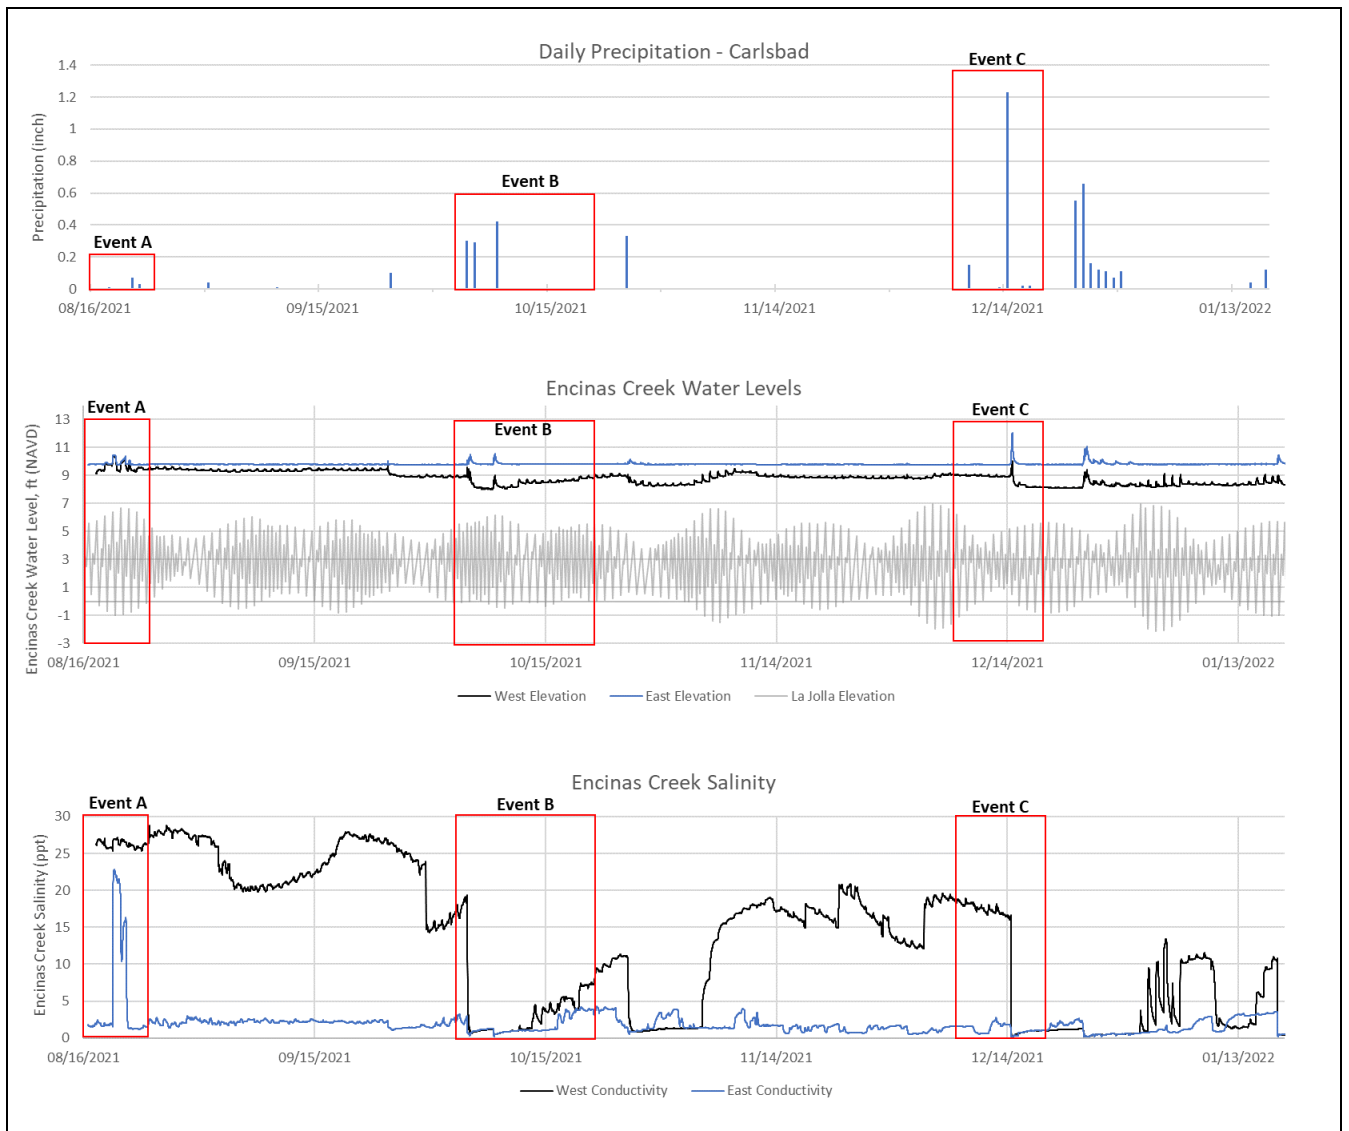
Figure 5-2. Daily Precipitation for McClellan-Palomar Airport (top); Encinas Creek & La Jolla (NOAA Tide Gauge 9410230) Water Levels (middle); Encinas Creek Salinity (bottom)

Between the events, the water levels and salinity concentrations equilibrate as can be seen in the monitoring data. Generally, water levels remain perched at or above the culvert sill elevations with salinity concentration ranging between 15-25 parts per thousand (ppt) in the west location and less than 5 ppt in east location. Between events, the west water levels show a mixed semi-diurnal tidal signature, which is result of wave overwash through the Southbound Carlsbad Boulevard culvert or through water seepage through the road prism. It should also be noted that during routine site visits, observations of kelp/seagrass deposits are common within the creek and variations in the sand (sill) deposition at the culvert/bridge crossing is common. An example of sill formation can be seen in Figure 5-3, which shows the culvert conditions at a timeframe of one month.

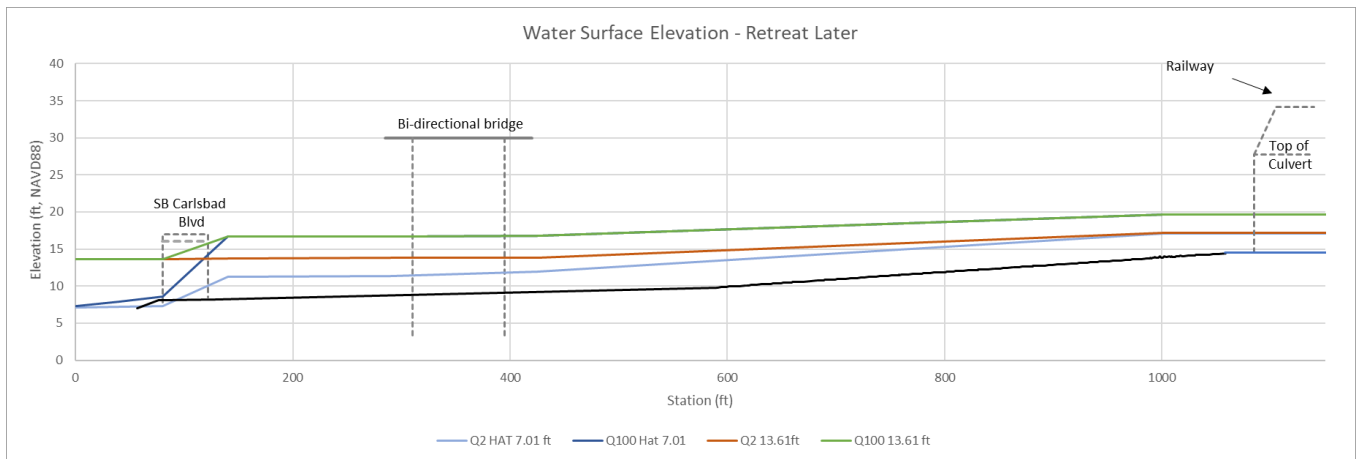
Figure 7-3. Modelled water surface elevation for Phased Adaptation Alternative

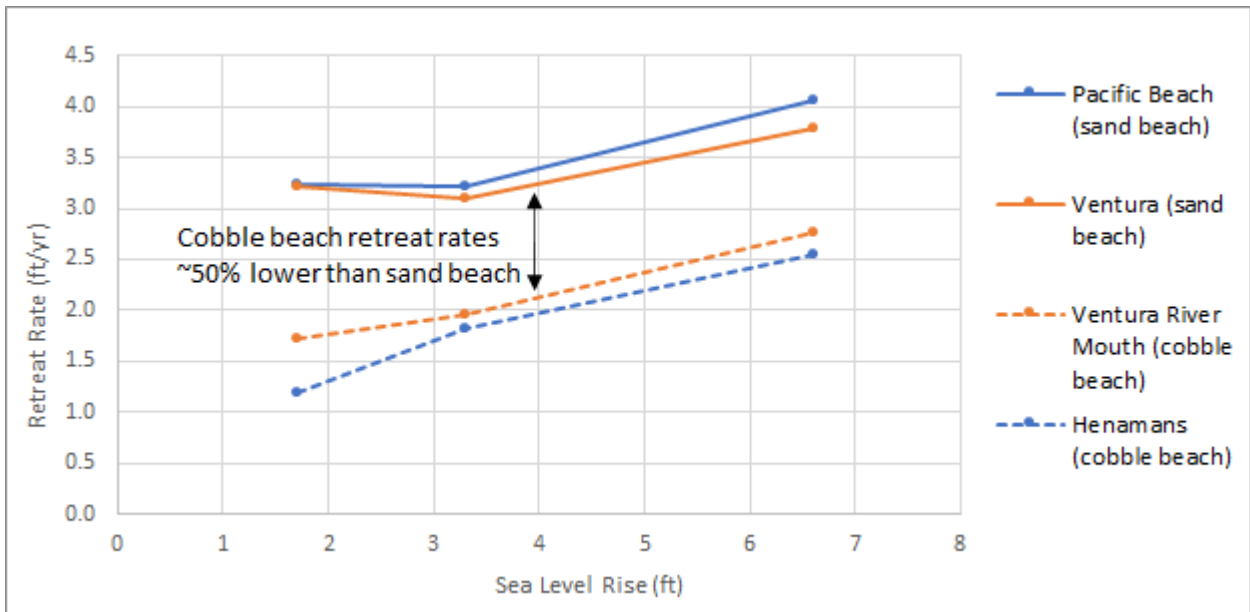
Figure 8-2 Comparison of Shoreline Erosion Rates for Henamans and Pacific Beach

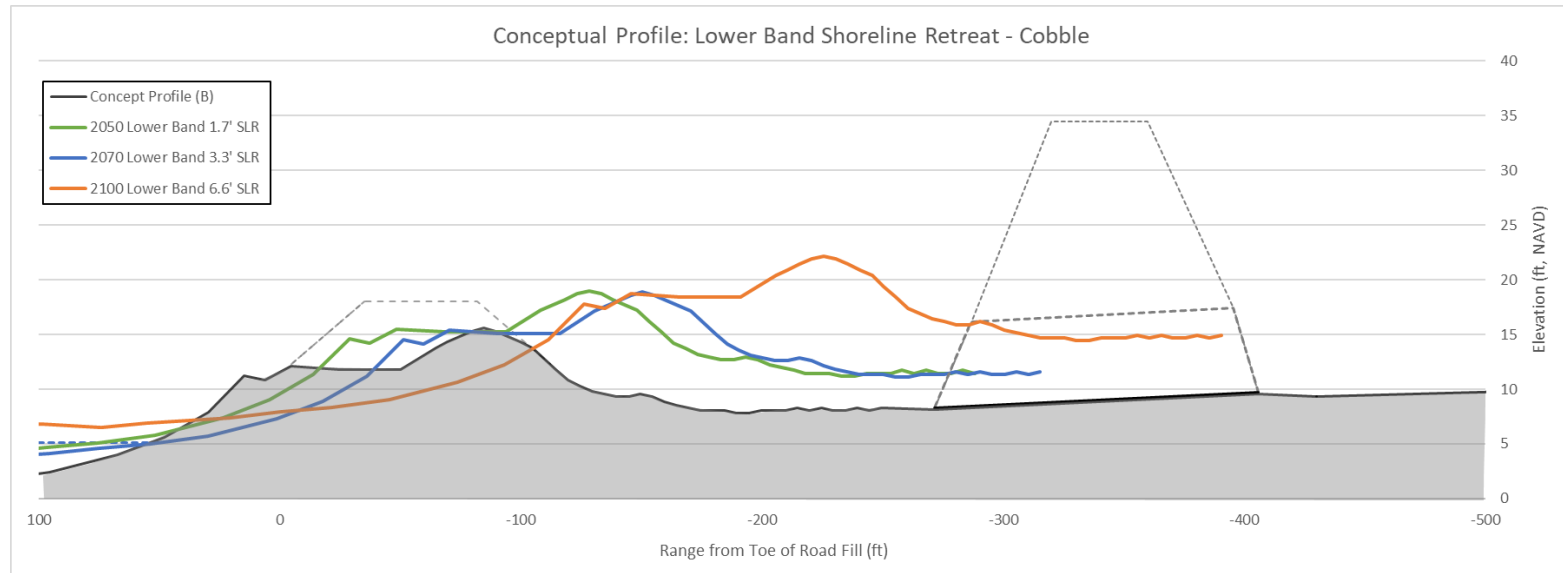
Figure 8-4. Shoreline Evolution Projections for Assumed Sand Dune (top) and Cobble/Sand Dune (bottom)

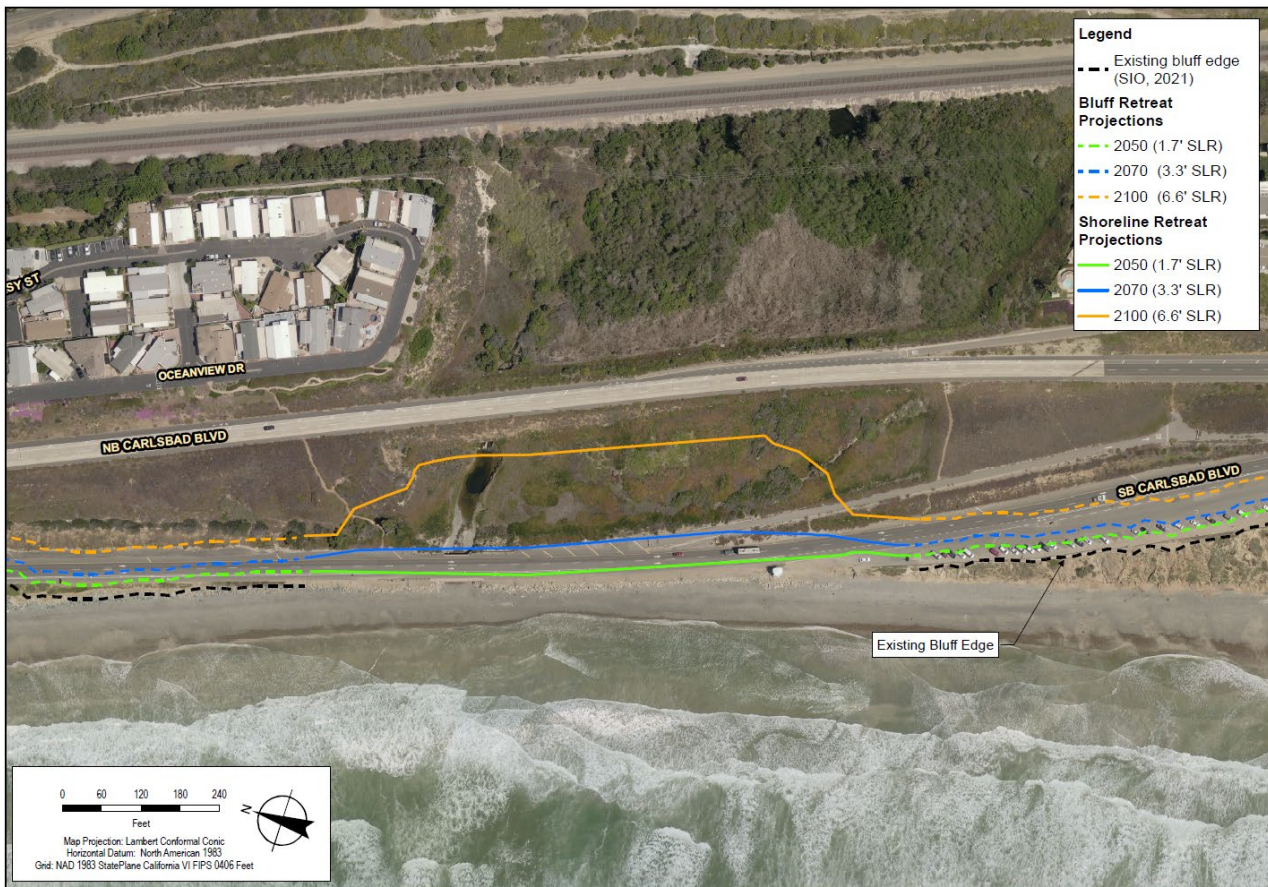
Figure 8-5. Shoreline vs Cliff Erosion Projection through Year 2100

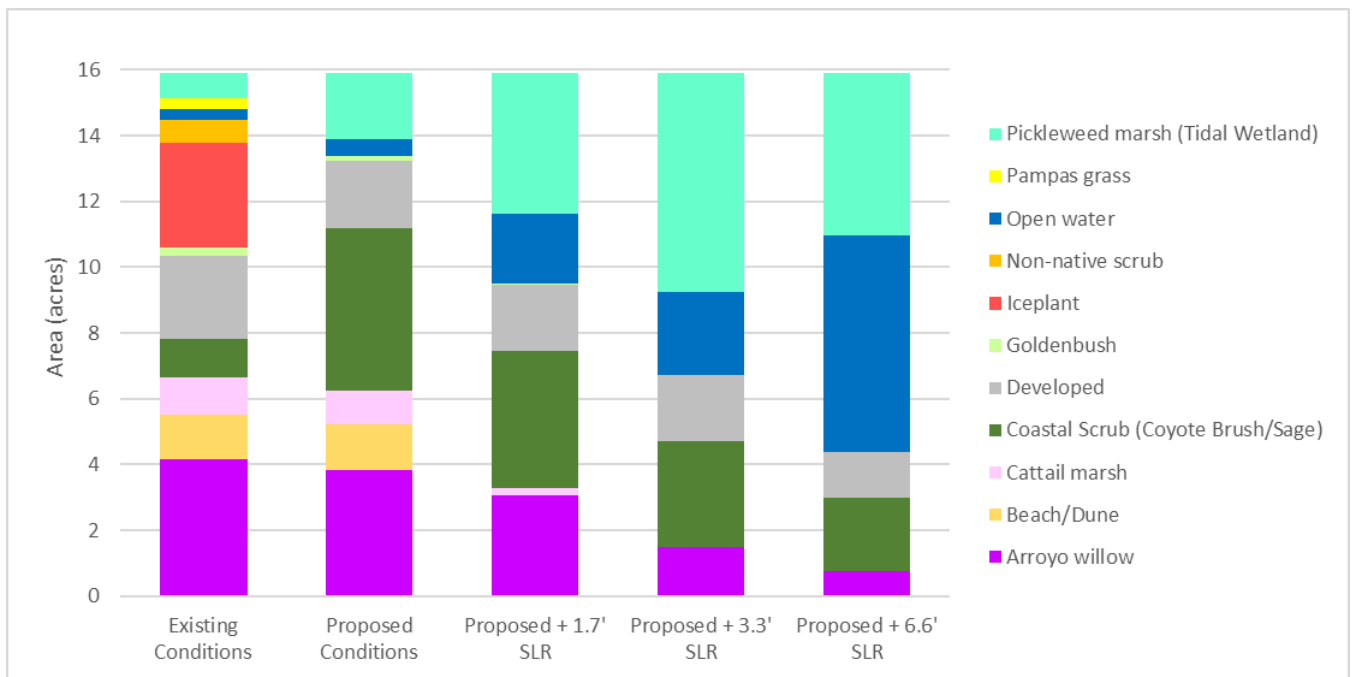
Figure 9-3. Habitat projections for projected SLR under the Phased Adaptation alternative

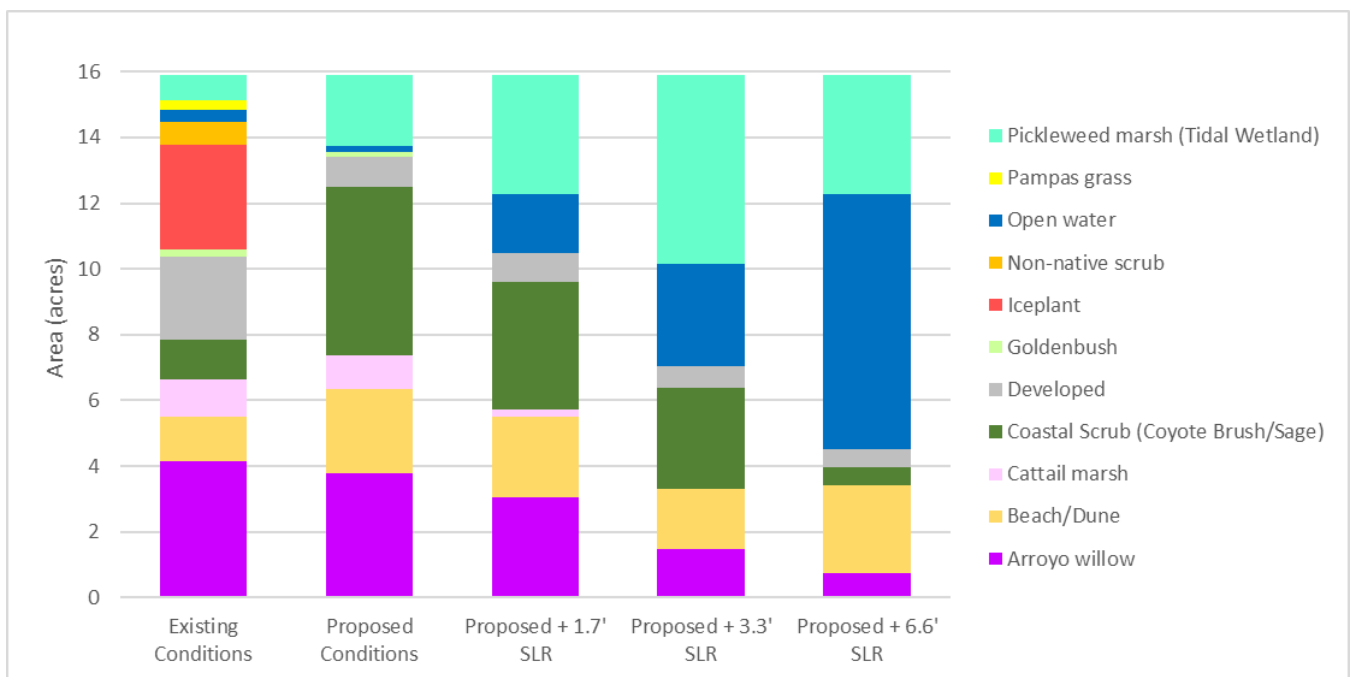
Figure 9-5. Habitat projections with projected SLR under Retreat Now alternative

- Arroyo willow and coastal scrub habitats will decrease from expansion of tidal wetlands and open water and over time with SLR the total area will evolve similar to the “No Project” and the Phased Adaptation alternative.

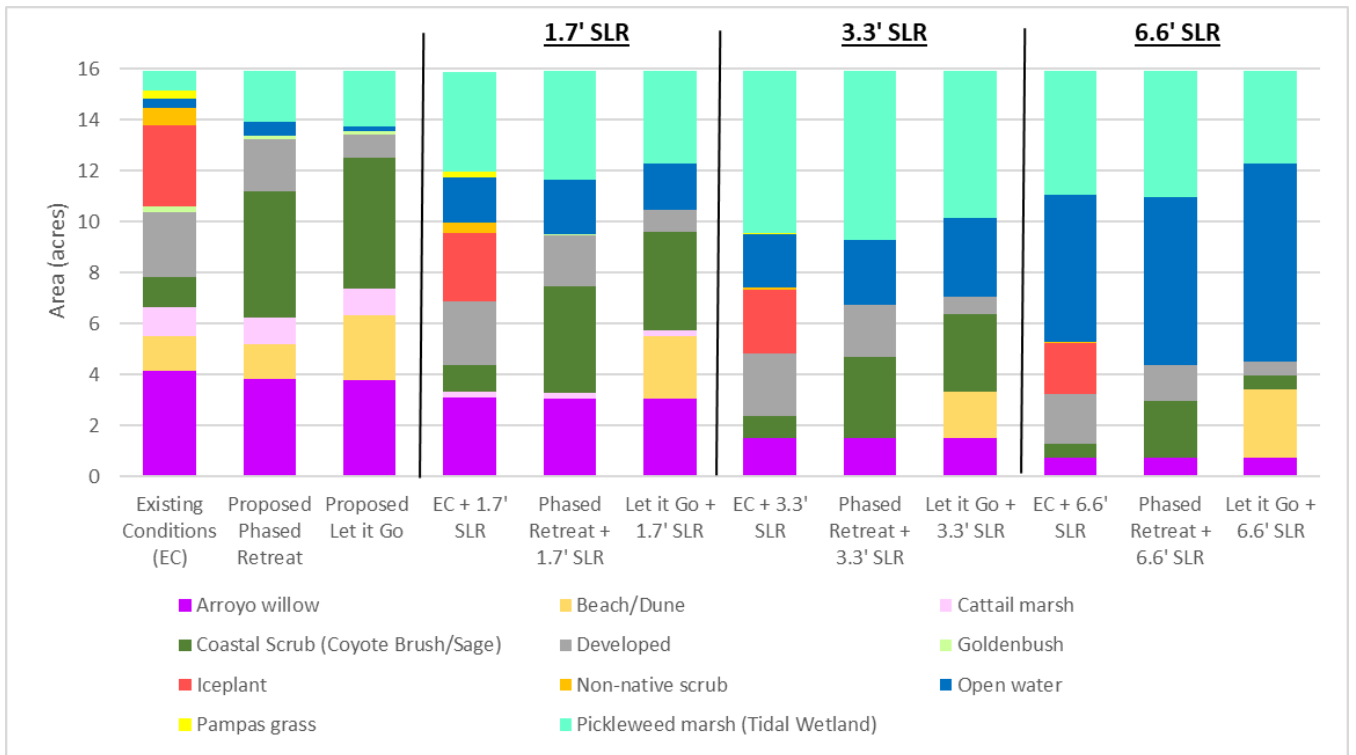
Figure 10-1. Comparison of Habitat Projections with Sea Level Rise for the Implementation Options

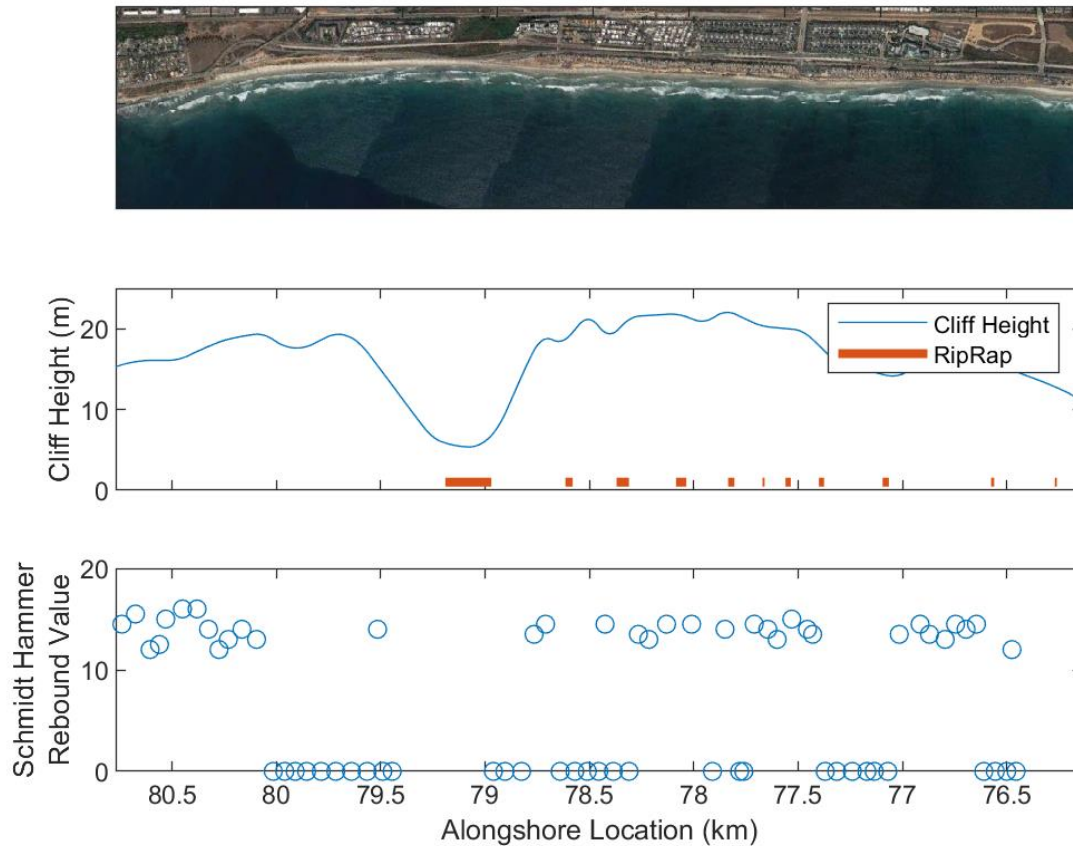
Figure 2. (Top) Aerial photograph of study area and (center) corresponding alongshore cliff height and riprap locations and (bottom) Schmidt hammer rebound values of rock hardness from Young (2018).

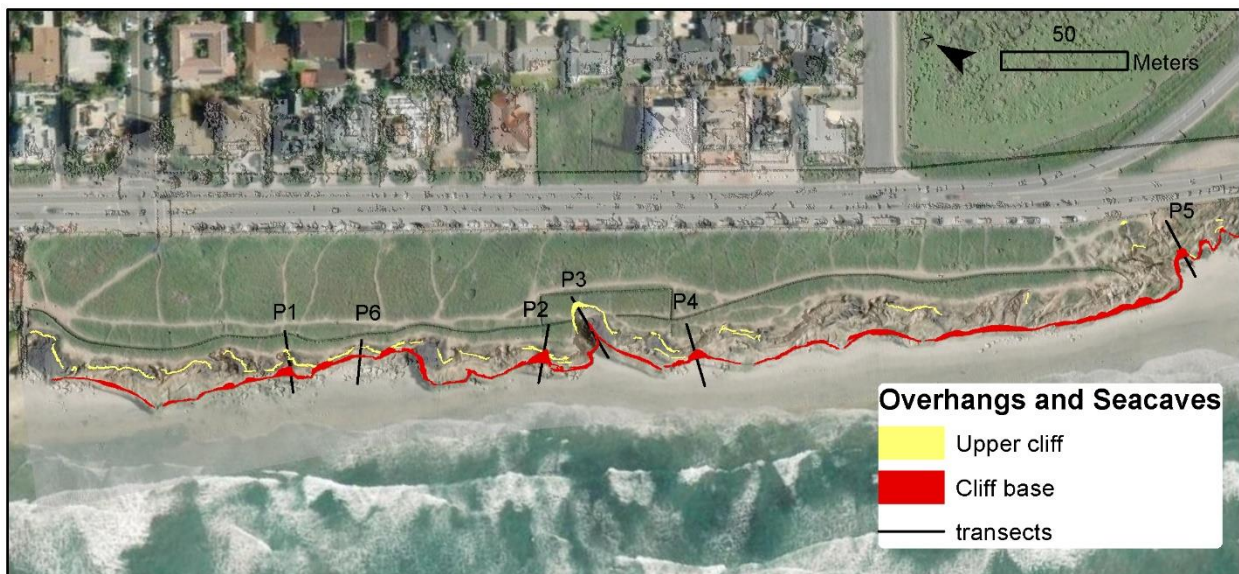
Figure 8. Areas with over-vertical topography in the upper and lower cliff obtained from a Sept. 17, 2020 LiDAR survey combined from drone- and truck-based mobile LiDAR systems. Labeled cross shore transects are shown in Figure 9.

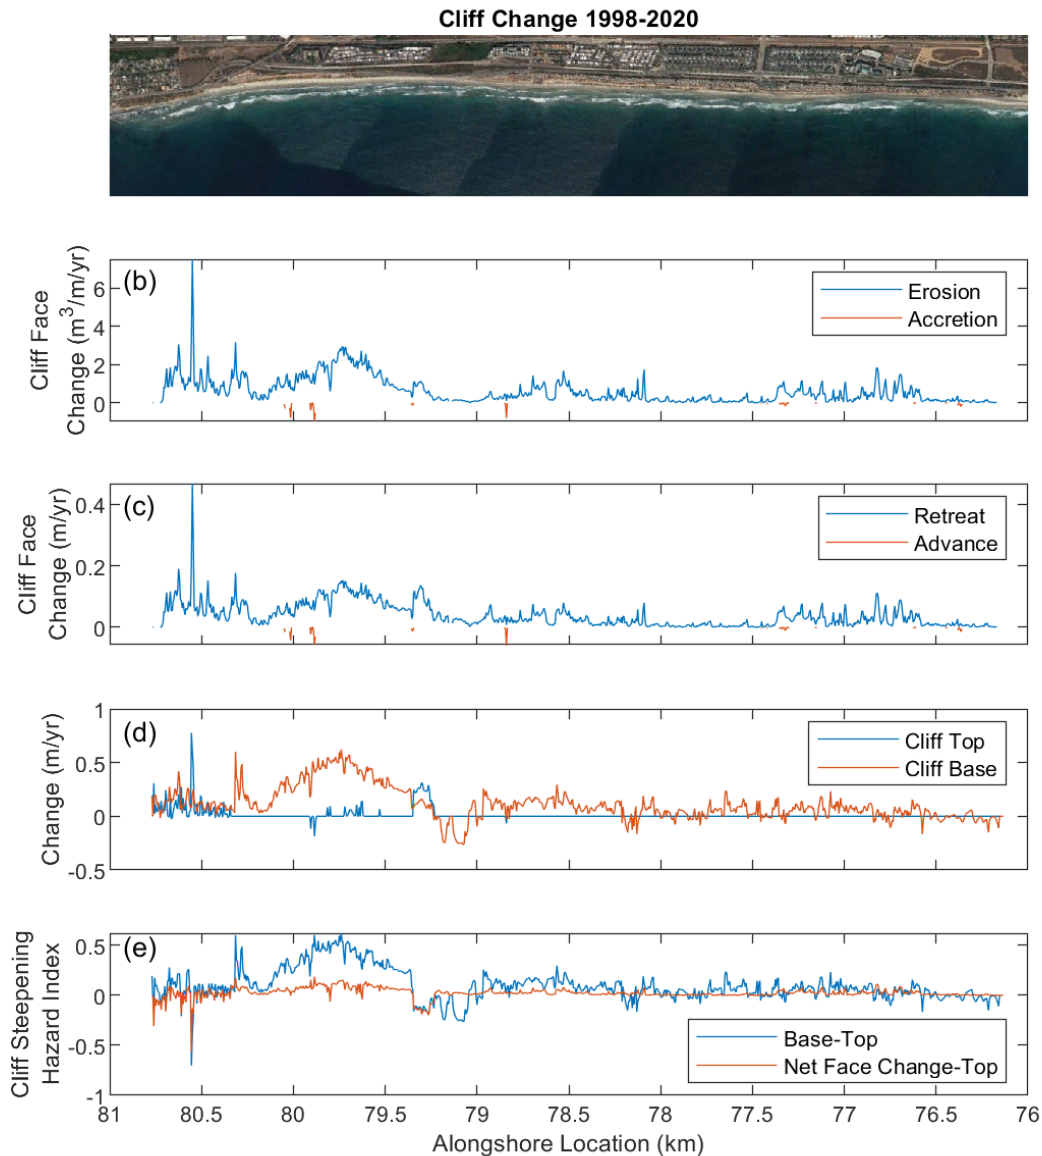
Figure 10. Cliff changes between 1998 and 2020 showing (b) volumetric change rate, (c) cliff face averaged retreat rates, (d) cliff top and cliff base change rates, and (e) a cliff steepening hazard index computed as the difference between lower and upper cliff changes. Higher values represent overall cliff steepening and increased cliff top retreat potential.
