Las Encinas Creek Habitat Restoration
Alternatives Analysis Report

City of Carlsbad

19 January 2023

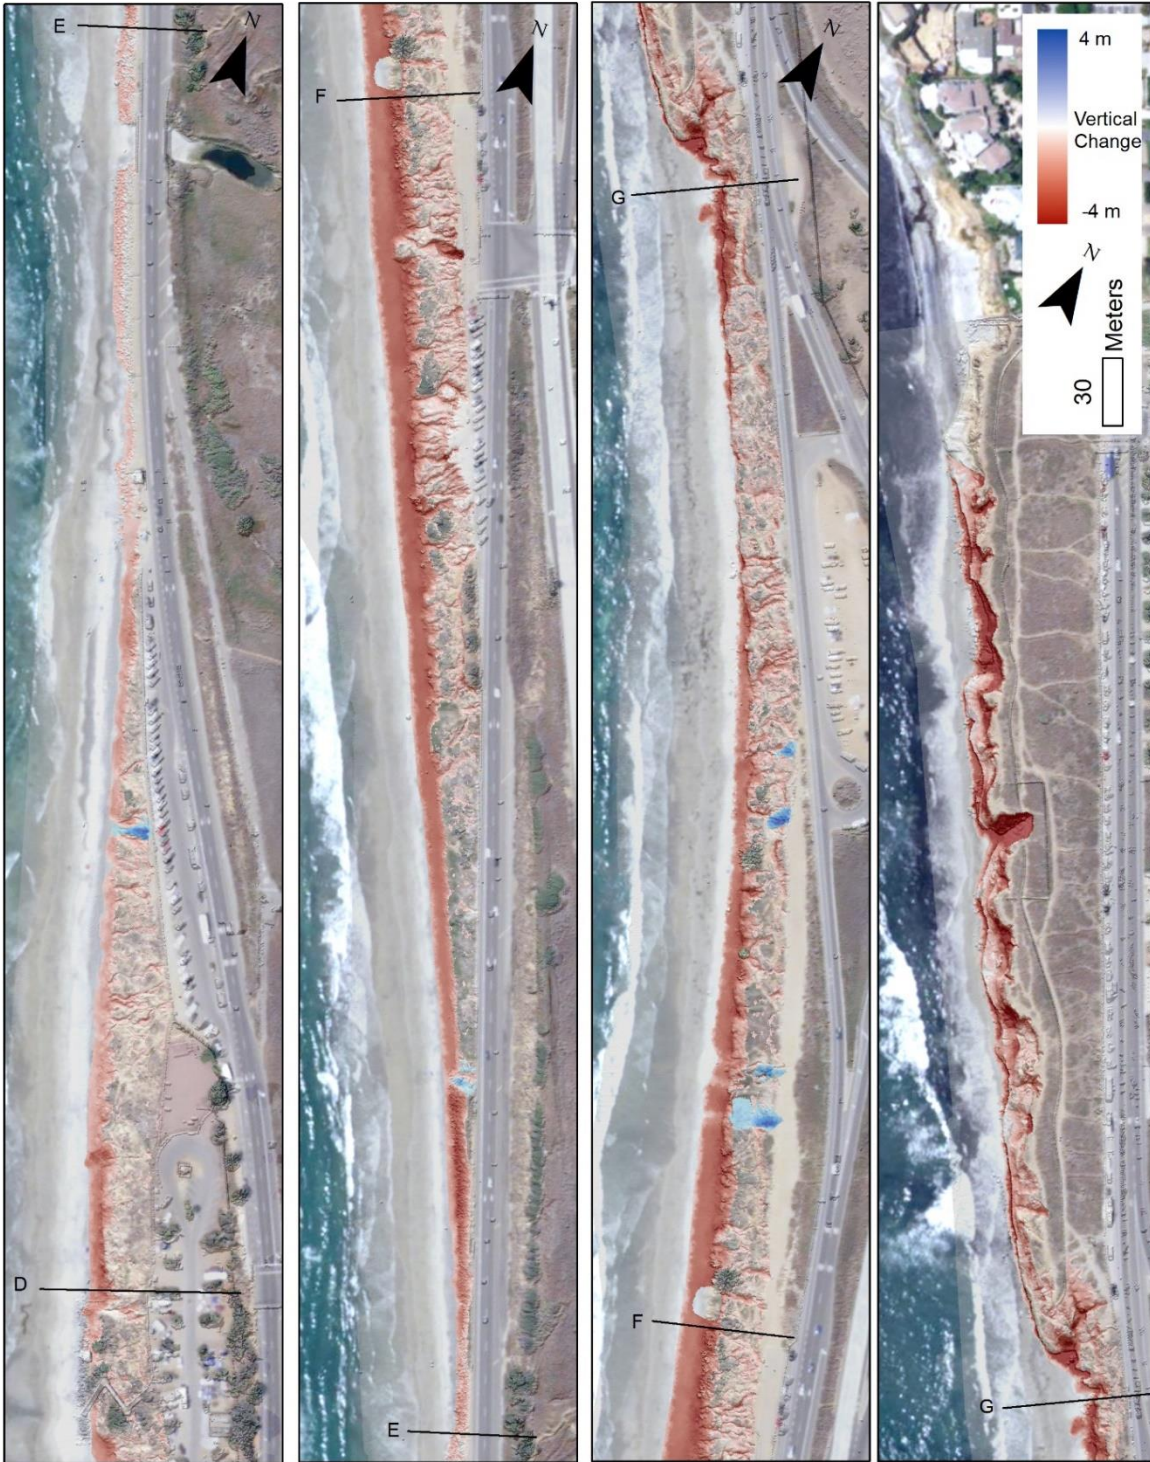
Figure 12. Vertical change maps of the north portion of the study showing erosion (red) and deposition (blue) between 1998 and 2020. Colors saturate at ± 4 m. From left to right, the panels go northward. Matchlines between panels and Figure 11 are indicated.

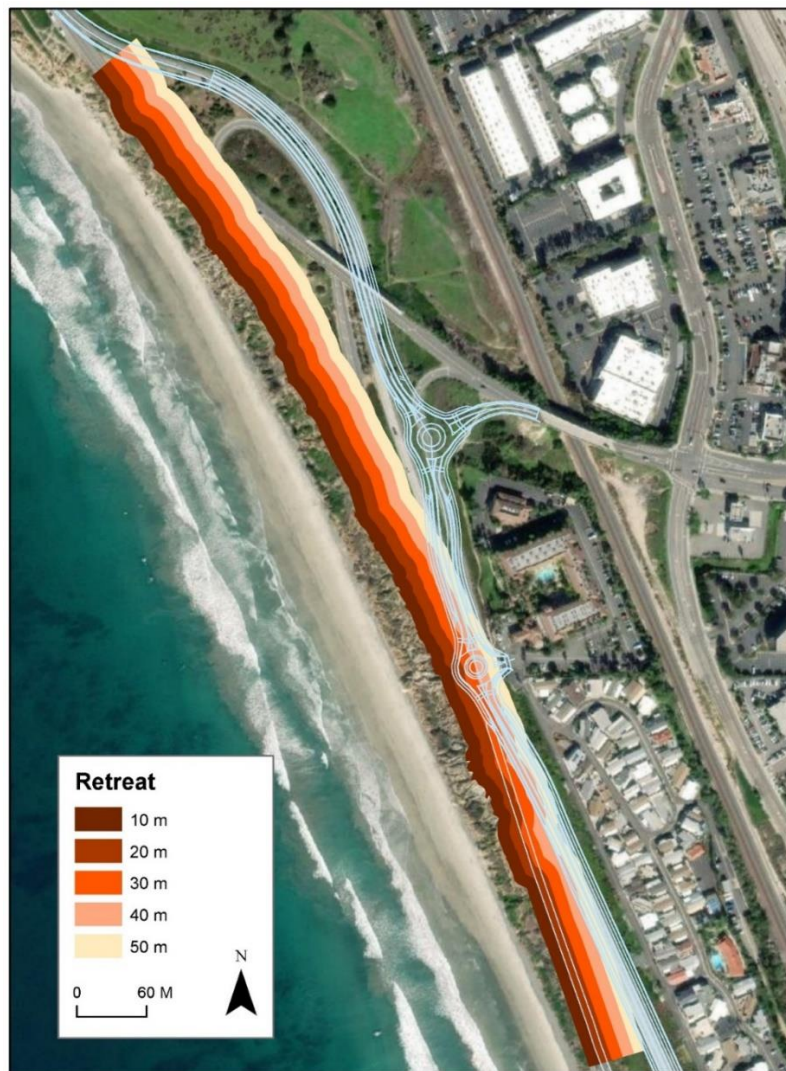
Figure 18. Map of the forecast area showing proposed road alignment and zones of cliff retreat relative to the 2020 cliff top position.

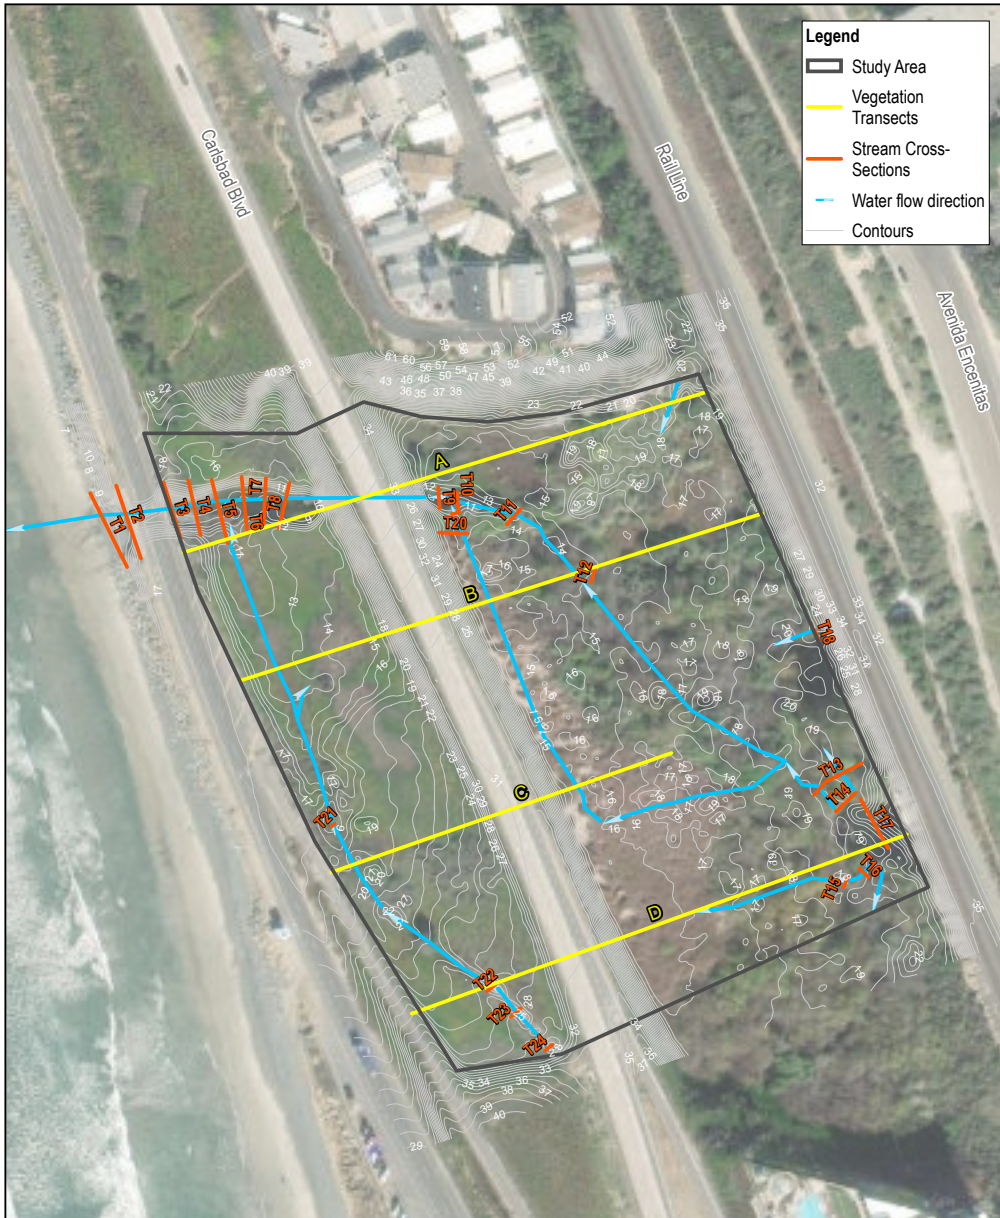
FIGURE 1

VEGETATION

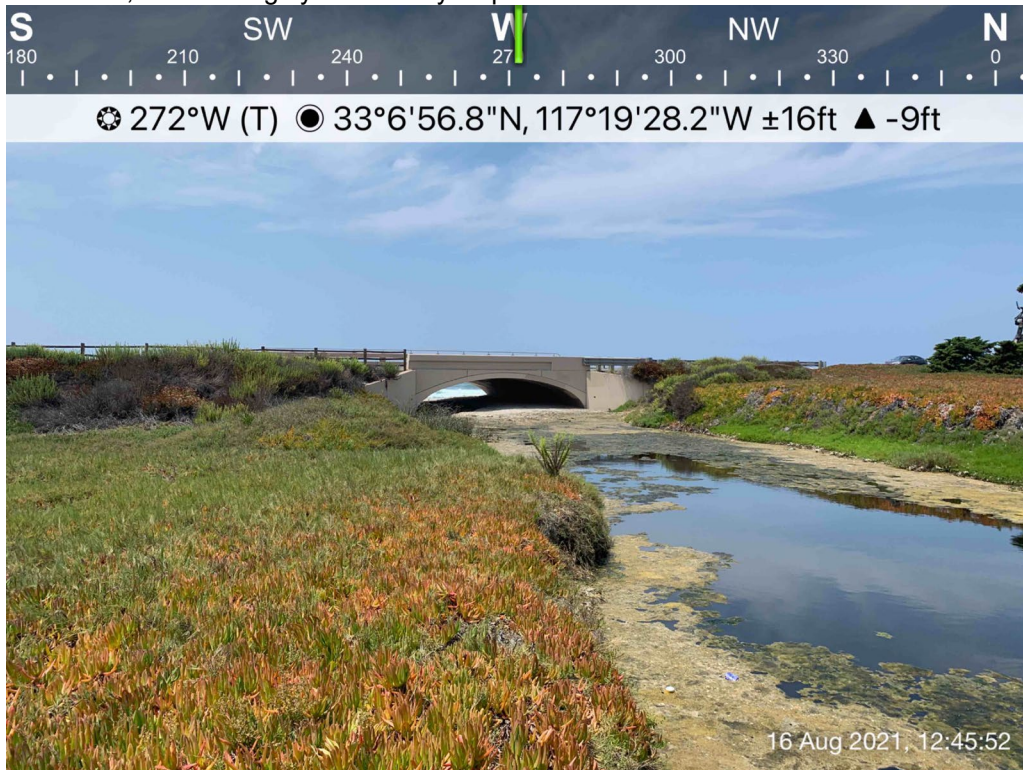
Photo 2. The mouth of Encinas Creek under southbound Carlsbad Boulevard.

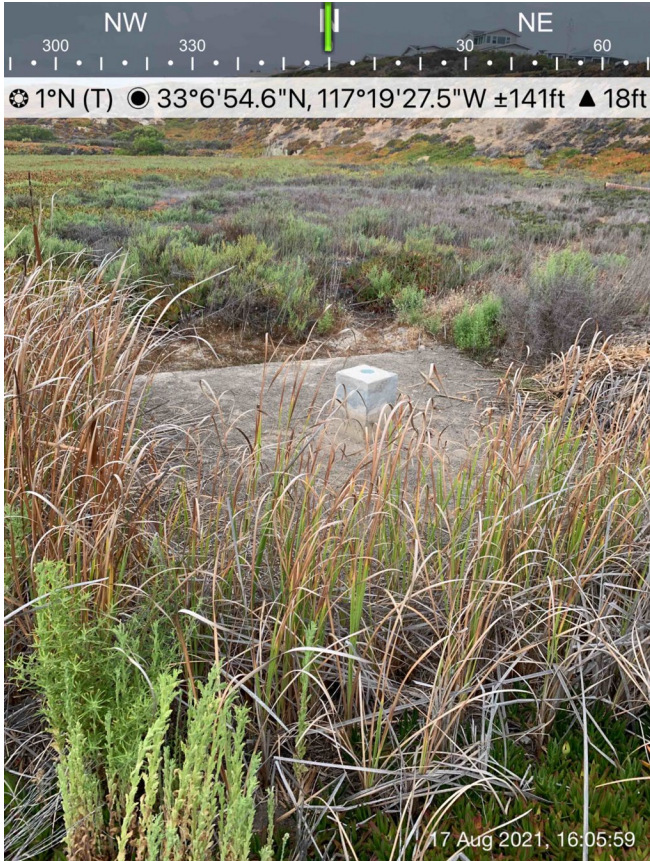
Photo 6. Pickleweed marsh south of Encinas Creek extended up to a concrete pad with a marker indicating the placement of the outfall pipe. Unusual patterns of dead vegetation and wetland plants such as cattails around the pad may indicate that the outfall pipe is another source of hydrology in the Study Area.

brackish water from wave runup and accumulate salt in the soil without getting flushed by flowing freshwater inputs like much of the area immediately surrounding Encinas Creek. Downstream of the culvert under Northbound Carlsbad Boulevard, the creek has been scoured approximately eight feet below the concrete double box culvert outlet approximately seven feet below Ordinary High Water Mark as indicated by undercut banks, breaks in slope, and vegetation type). The mouth of Encinas Creek was mostly blocked by beach sand accreting on the concrete arch culvert sill, with a very low flow observed under Southbound Carlsbad Boulevard during the August field investigation. Lower Encinas Creek, bound by North- and Southbound Carlsbad Boulevard, was surrounded by brackish to salt marsh vegetation (e.g. pickleweed and Menzies goldenbush) and appeared to have some regular tidal influence with ocean waves likely overtopping the accreted sand at higher tides. South of the Encinas Creek mouth, a concrete pad exists with a marker indicating the presence of a stormwater outfall pipe. Unusual patterns of dead vegetation and wetland plants, such as cattails, around the pad may indicate that the outfall pipe is another source of hydrology onsite.

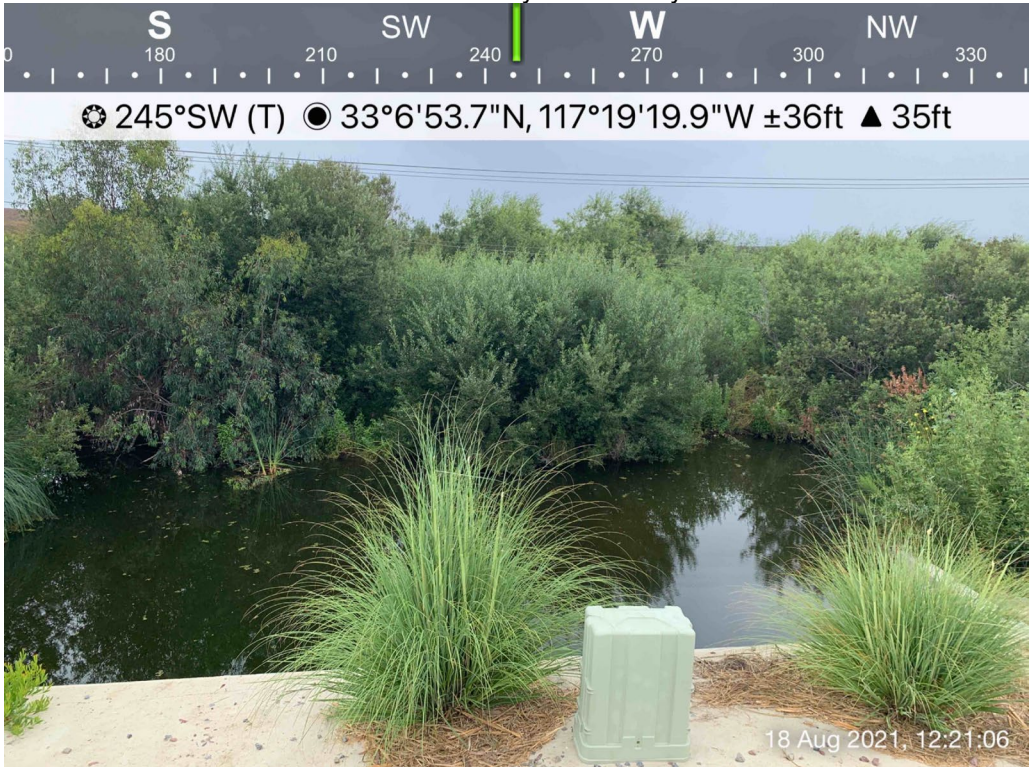
Photo 14. Dense arroyo willow surrounded the scour pool at the large Avenida Encinas culvert outlet.

Encinas Creek’s hydrology appears to have been highly altered by urbanization upstream and in the surrounding area. Urban stormwater runoff has likely increased peak flow volumes, and channelization of Encinas Creek immediately upstream of the site has likely increased flow velocity. A deep scour pool occurred at the large culvert outlet below Avenida Encinas at the south-eastern end of the Study Area (**Appendix B Photos 24-25**), and seasonal channels radiate out from the pool, with one small perennial channel flowing west into the cattail marsh (**Appendix A Figure 2, Appendix B Photo 26**). Water flowing approximately due west from the Avenida Encinas culvert and scour pool into the cattail marsh might have diverted flow away from the larger historic Encinas Creek channel, which had already run dry at the time of the mid-August surveys. The upper portion of the larger channel through the willow scrub has become braided and has lost a clearly defined bed, bank, and channel through much of the upper portion. The cattail marsh and seasonal channels through the willow scrub coalesce into the widened perennial creek on the north end of the site near the culvert under northbound Carlsbad Boulevard. There has likely been a major increase in peak flows that have substantially changed the hydrology of Encinas Creek as indicated by the scour pool, apparent change in dominant flow direction, and lack of a clearly defined creek bed and bank through most of the eastern portion of the Study Area.

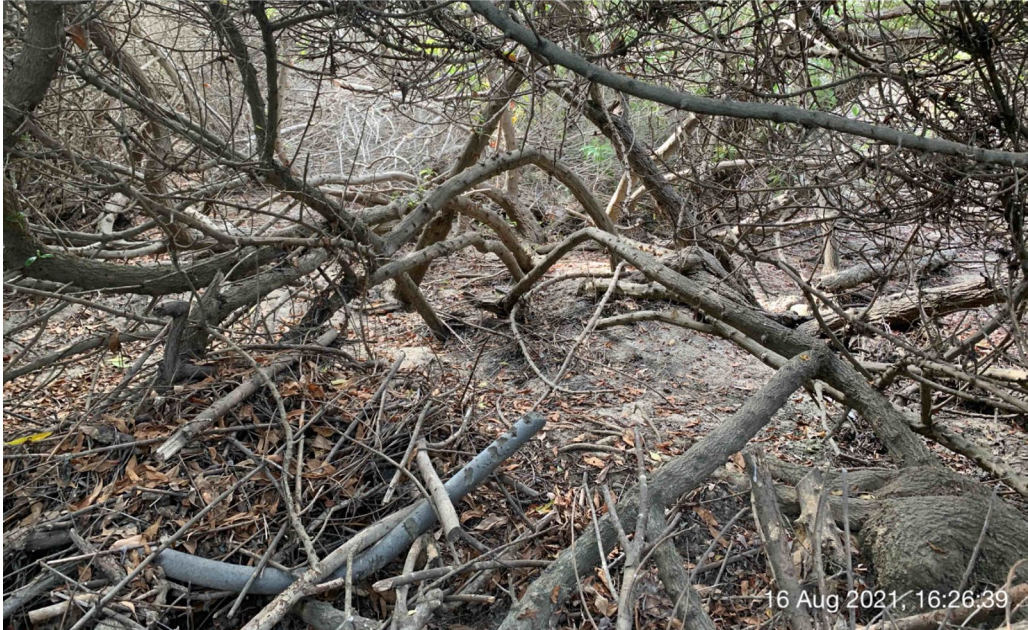
Photo 15. Dry braided channels and sediment deposits within the willow thicket.

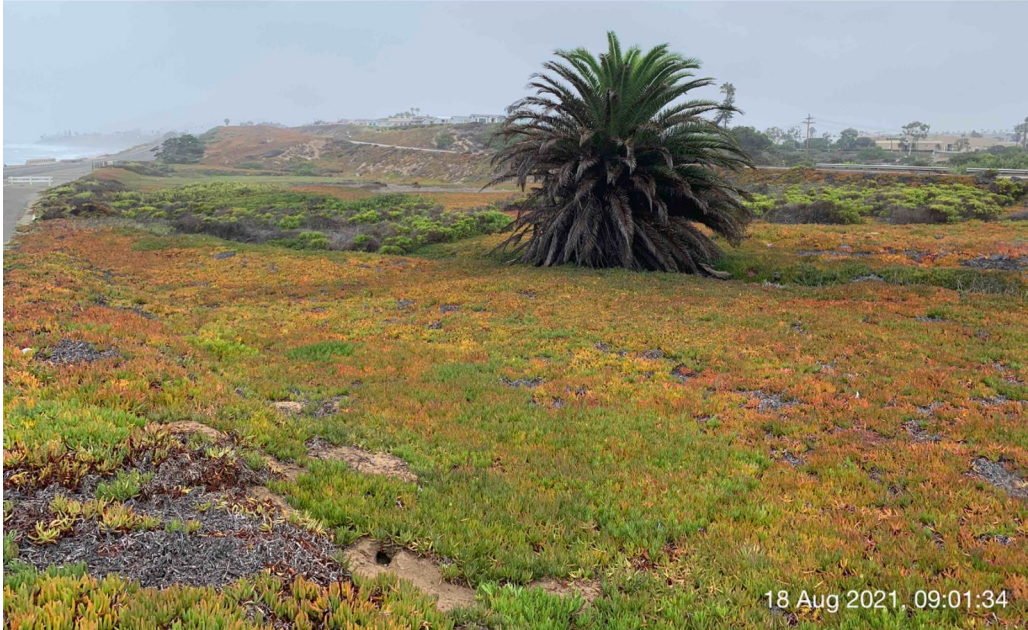
3°N (T) 33°6'50.4"N, 117°19'26.6"W ±75ft ▲ 39ft

Photo 23. Iceplant has widely invaded the site and dense mats cover large areas of the Study Area.

Freeway iceplant (Cal-IPC High) has severely invaded 2.37 acres of the Study Area and established thick monospecific mats throughout much of the western portion of the Study Area and on both sides of northbound Carlsbad Boulevard (**Appendix B Photo 23**). Freeway iceplant was observed at a wide range of elevations onsite (~9-33ft NAVD) and appeared to be invading brackish wetland and upland habitats.

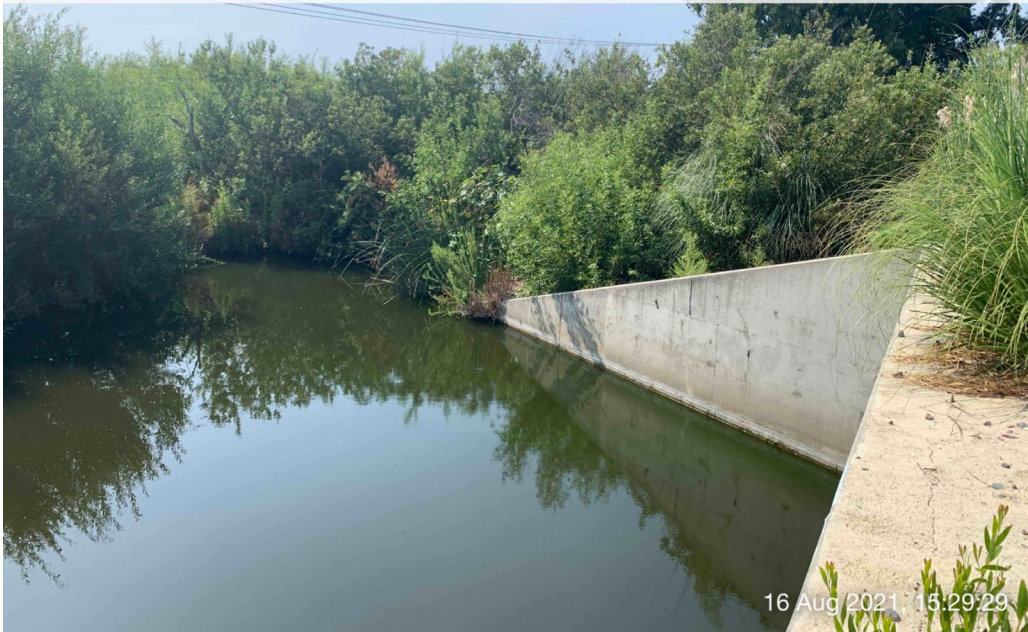
304°NW (T) 33°6'53.8"N, 117°19'20.1"W ±13ft ▲ 32ft

Photo 24. A large scour pool occurs at the outlet of the large culvert under Avenidas Encinas.

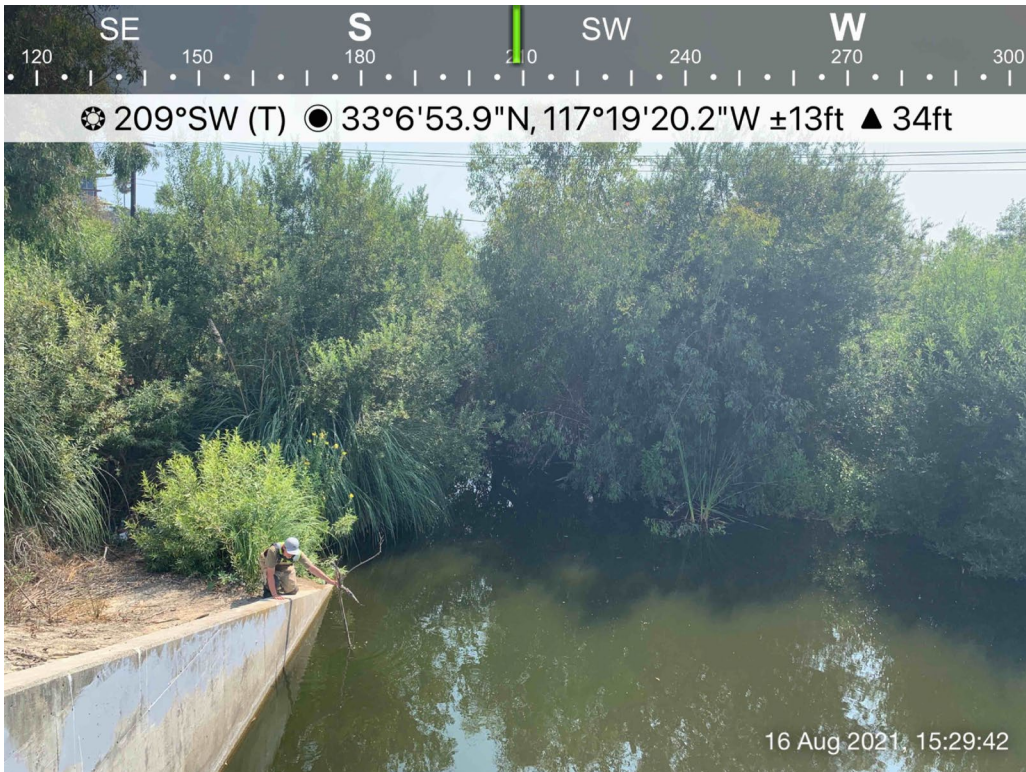
Photo 25. The large scour pool appeared to be deep at the center, and depth at the thalweg is unknown.

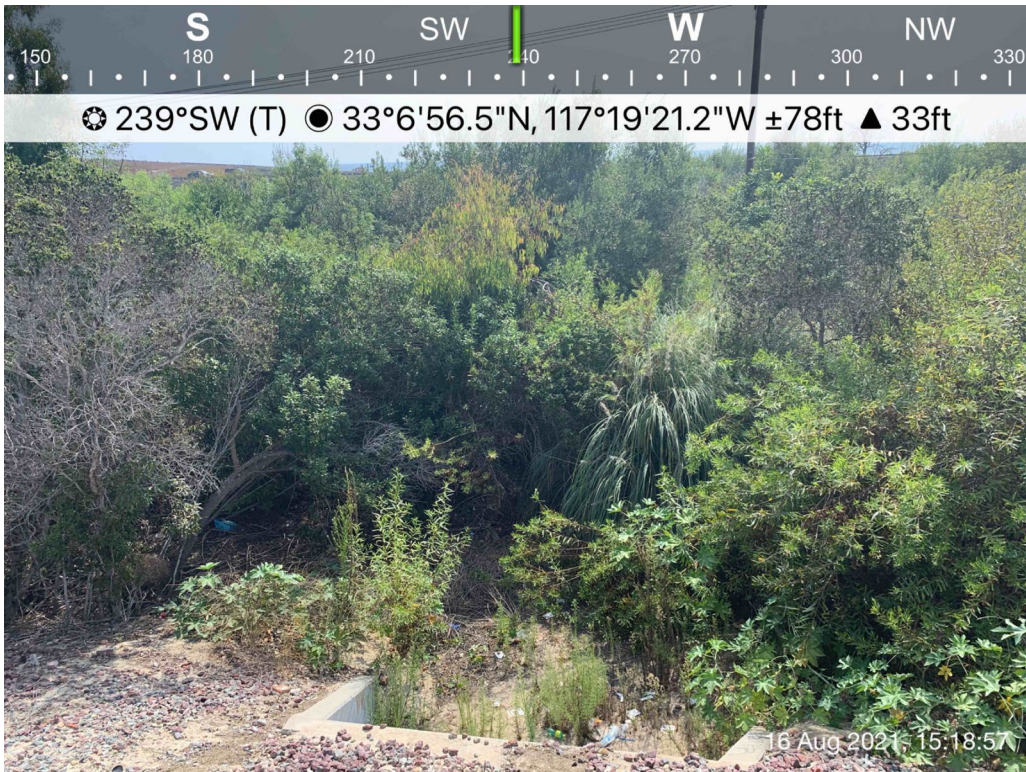
Photo 27. A smaller culvert outlet under Avenida Encinas provides an additional source of seasonal hydrology.

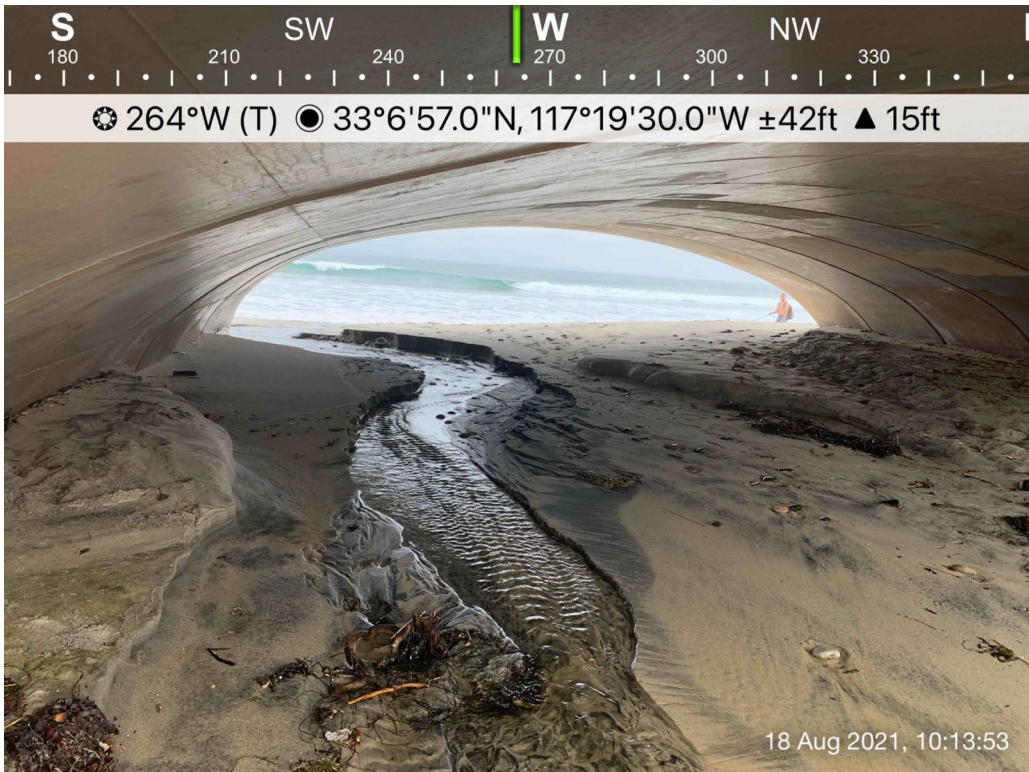
Photo 29. The culvert at southbound Carlsbad Boulevard has accreted beach sand and a low flow trickle drained Encinas Creek to the ocean outlet at the time of the August surveys.
